# Direct Tension and Cyclic Testing of JFE SPF Wave Feature

JFE Engineering Corporation  
Yokohama, Japan

Cornell University  
School of Civil and Environmental Engineering  
Cornell University  
Hollister Hall  
Ithaca, NY 14853  
March, 2018

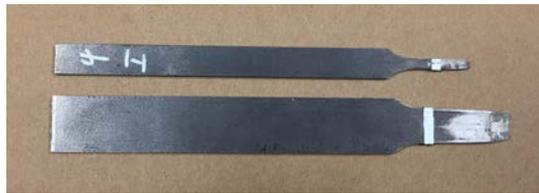
Figure 2.2. Size comparison of wall cut coupon specimens

Due to the thin wall and curvature of the specimens, ASTM - E8 2013 (ASTM 2013) could not be followed. The nominal dimensions of the ASTM standard tensile coupons are shown in Figure 2.1. Dimensions C and W were reduced to 0.4 in. and 0.15 in (10.2mm and 3.81mm), respectively. The ASTM standard does not identify a specific wall thickness. Each coupon had a nominal thickness,  $t$ , of 0.091 in. (2.3 mm), the thickness of the pipe wall. A comparison of size for specimens described in this section relative to those complying with the ASTM standard is provided in Figure 2.2.

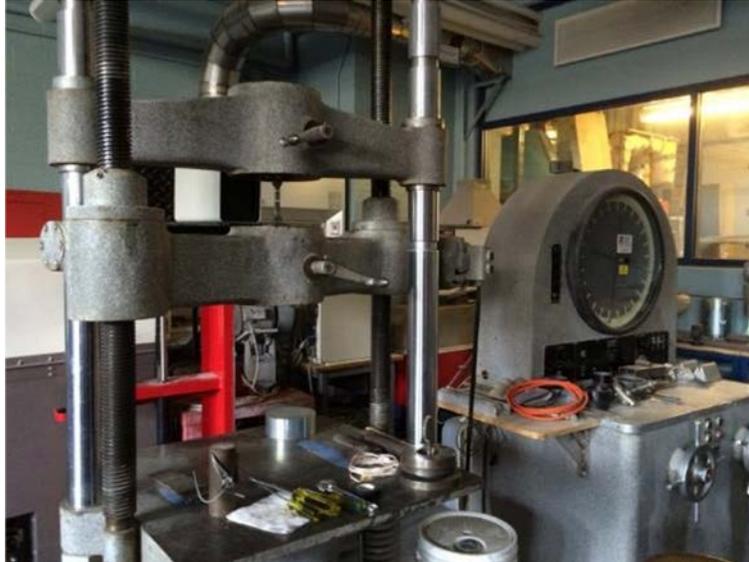
Figure 2.3. Baldwin testing apparatus

A Baldwin Hamilton 60 BTE Universal Testing Machine was used to apply tensile loads. The load frame was fitted with a pressure sensor to measure applied force. The machine was calibrated in March of 2017. A photo of the test setup is provided in Figure 2.3.

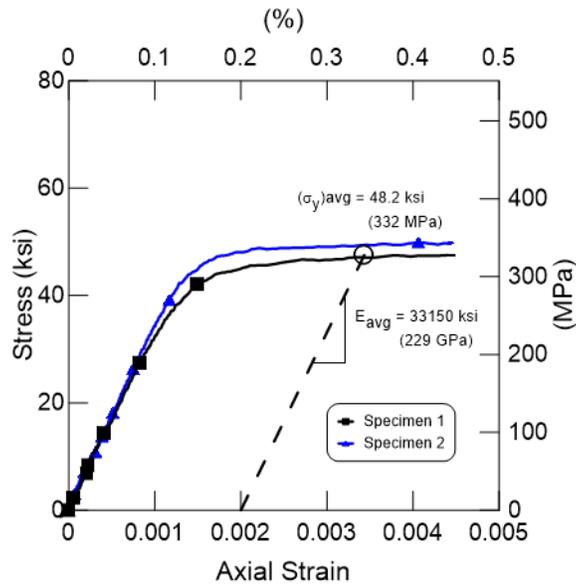
Figure 2.6. Average Young's modulus and yield stress

An expanded view of the stress vs. strain data is shown in Figure 2.6, in which the combined strain gage and laser extensometer data were used to plot stress vs. strain within and beyond the elastic range. At the end of the elastic range, locally variable readings were obtained with the bondable gages, and preference beyond this range was given to the laser extensometer data in developing the stress vs. strain relationship.

Young's modulus was computed using the elastic range of the stress vs. strain curve and a combination of the bonded axial strain gage and extensometer data. These data are shown to a

strain of 0.0045 in Figure 2.6. Young's Modulus was determined by performing a linear regression for stress vs. strain from 5 ksi to 35 ksi (34 to 241 MPa). The yield strength,  $\sigma_y$ , was computed using the offset method, in which a line parallel to the linear part of the stress vs. strain plot is projected from 0.2% strain. The intersection of this line and the stress vs. strain curve provides an estimate of the yield stress for each specimen. The Young's modulus and yield stress for the specimens are presented in Table 2.1. The average Young's Modulus is 33,200 ksi (229 GPa). The average yield stress is 48.3 ksi (333 MPa).

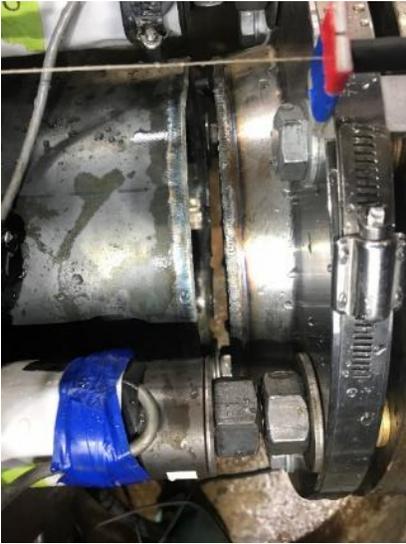
Figure 3.4. TTS north end cap failure

this initial step, local yielding of the restraining rods was observed in the north end causing bending of the endcap. These rods were replaced with high strength rods for the next loading step. Global displacements were corrected in the data by use of the N2N string pot measuring north end displacement. The actuator was reset and moved an additional 0.8 in. (20mm). A failure at the north end cap, shown in Figure 3.4, occurred by means of weld fracture. The pipe accommodated a total displacement of 4.4 in. (112 mm) at a maximum force of 135 kips (600 kN).

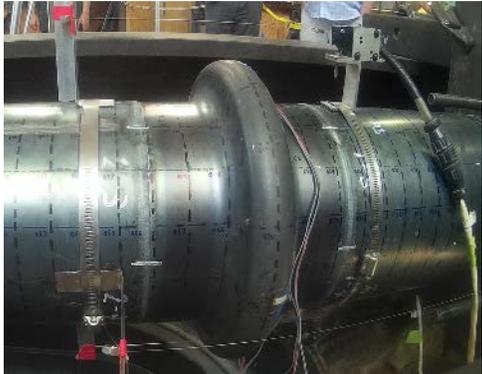
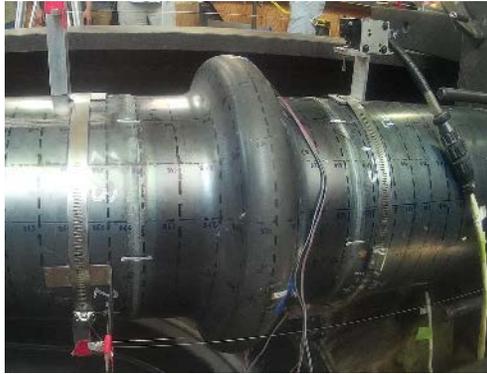
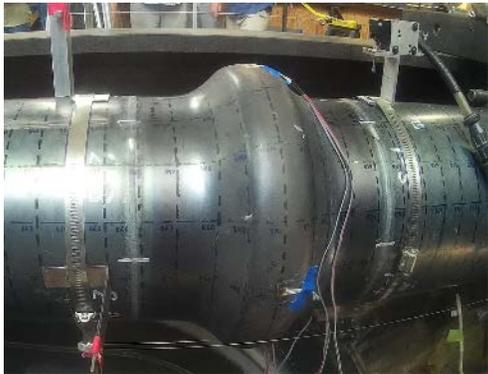
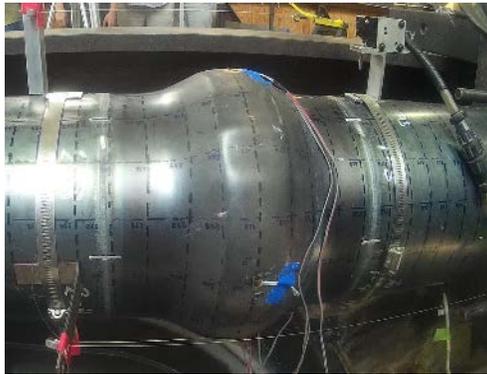
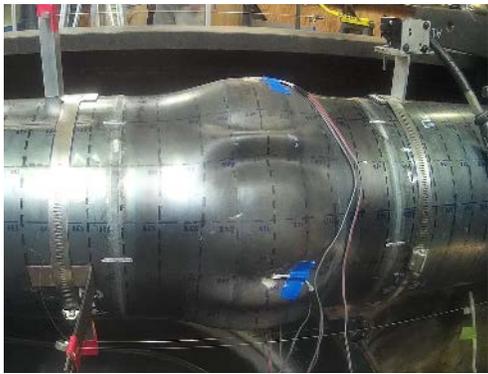
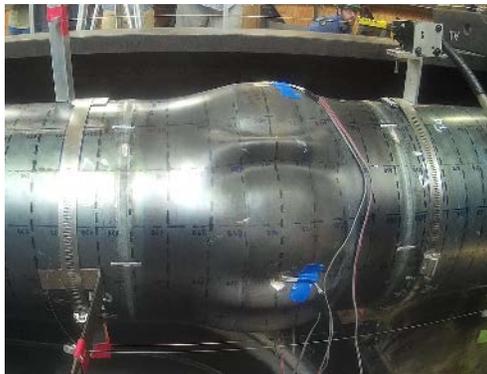
Figure 3.6. TTW1 SPF at several tensile deformation levels

This section covers the results of the first tension test on a pipe specimen with an SPF wave feature. For the remainder of the report and all subsequent figures, this test is referred to as TTW1. Figure 3.6 (a)-(f) shows the SPF at approximately 0, 1.0, 2.0, 2.5, 3.0, and 3.5 in. (0, 25, 50, 64, 76, and 89 mm) of actuator imposed deformation, respectively. The pipe failed due to a weld failure at the south flange at a actuator displacement of 5.4 in. (137 mm) and force of 133 kips (592 kN). As the pipe was pulled in tension the wave feature compressed in the circumferential direction, resulting

in reduction of the cross-sectional area of the wave and circumferential buckling. The beginning of buckling is shown in Figure 3.6 (d).

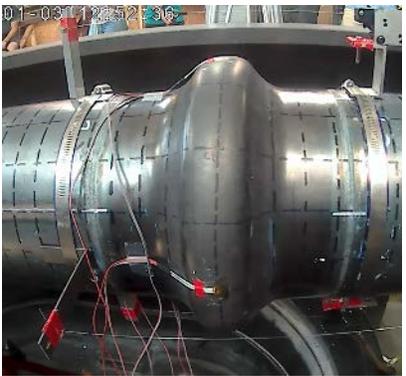
Figure 3.12. TTW2 images of SPF during cyclic motion

Figure 3.12(a)–(i) show photographs of the SPF during cyclic motions. Each figure, (a) through (i), corresponds to their respective letters in Figure 3.11 (a). After the first compressive movement, the SPF returned to a geometry configuration nearly identical to its undeformed shape, as shown in Figure 3.12 (a)-(c). The first compressive step of the cyclic displacement [Figure 3.12(e)] induced SPF deformation out of plane with the vertical. Figure 3.12 (g) and (h) show that similar out of plane movement was observed in the second compressive step as well as the return to 0 axial displacement.
