Performance Evaluation of iPVC Pipe under Earthquake-Induced Ground Deformation

Cornell University

December, 2018

This report is submitted to the Pyungwha Pipe Industry Co., Ltd. (herein referred to as PPI). It presents the results of a full-scale testing program to investigate the performance of 6-in. (150-mm)-diameter polyvinyl chloride pipe with a minimum wall thickness of 0.383 in. (9.73 mm), commercially available as iPVC pipe, with restrained joints. Testing was performed to evaluate how pipelines composed of iPVC pipe accommodate large ground deformation. In particular, the testing program was focused on pipeline response to fault rupture. Fault rupture is not only a major ground deformation hazard associated with earthquakes, but is representative of the most severe seismic ground deformation that occurs along the margins of liquefaction-induced lateral spreads and landslides.

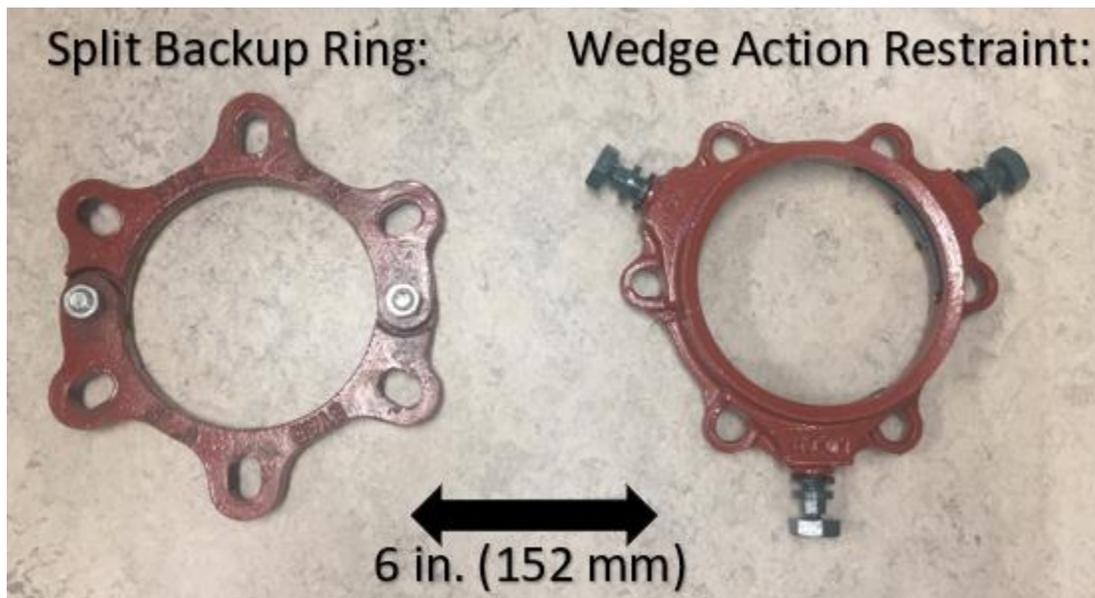
Figure 1.1. Split Backup Ring and Wedge Action Restraint

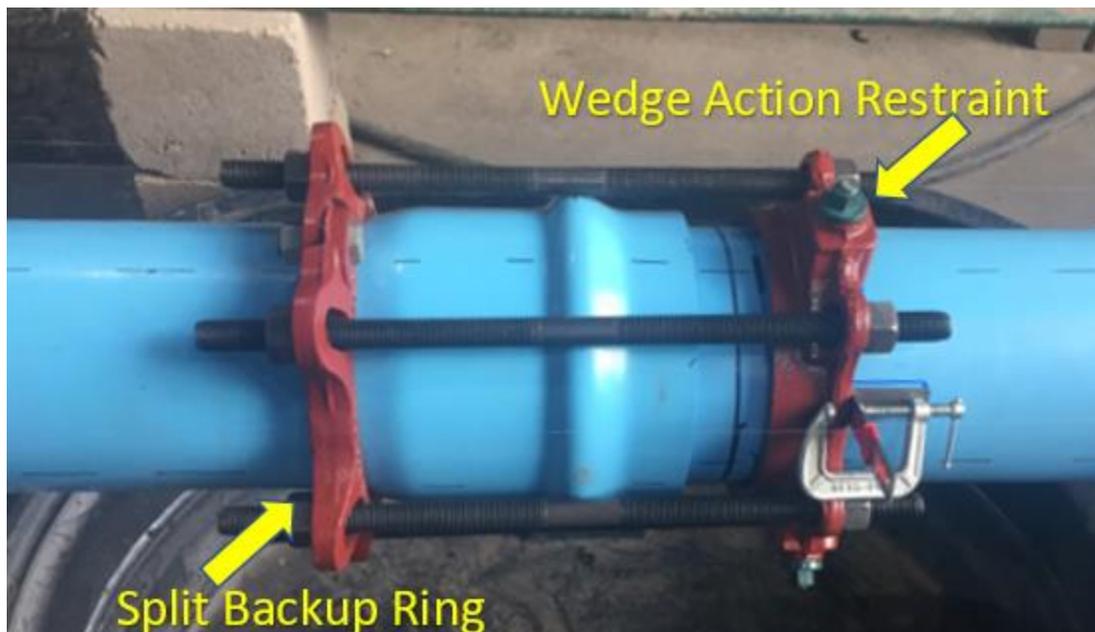
Figure 1.2. Typical Installation of Restraining Joint on iPVC

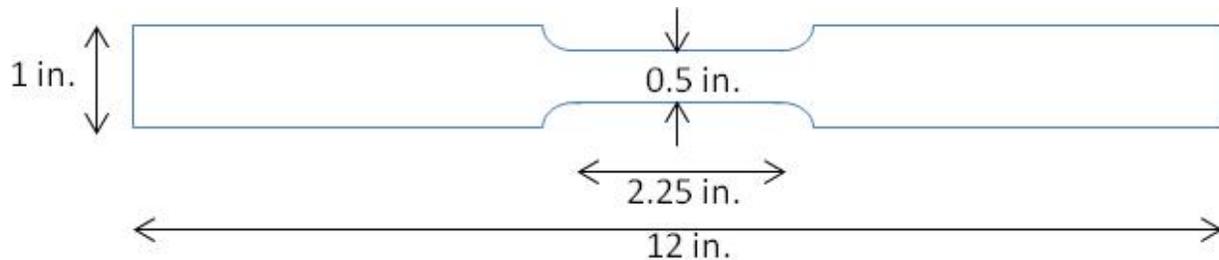
Figure 2.1. Schematic of iPVC Tensile Coupon Specimen

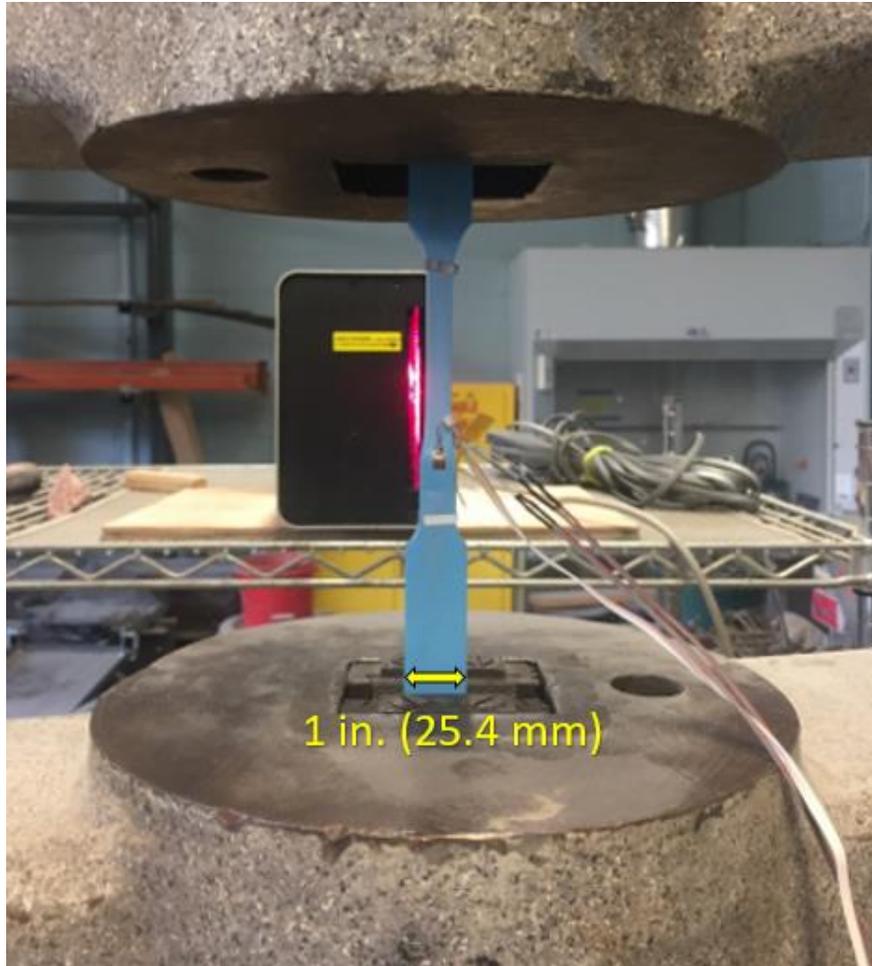
Figure 2.2. Tensile Coupon Test Setup with iPVC Material

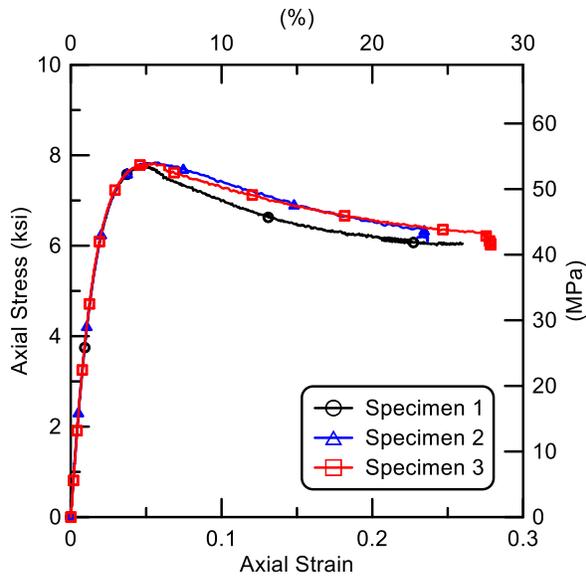
Figure 2.3. Stress vs. Strain Curve to Failure Using Clip-on Extensometer

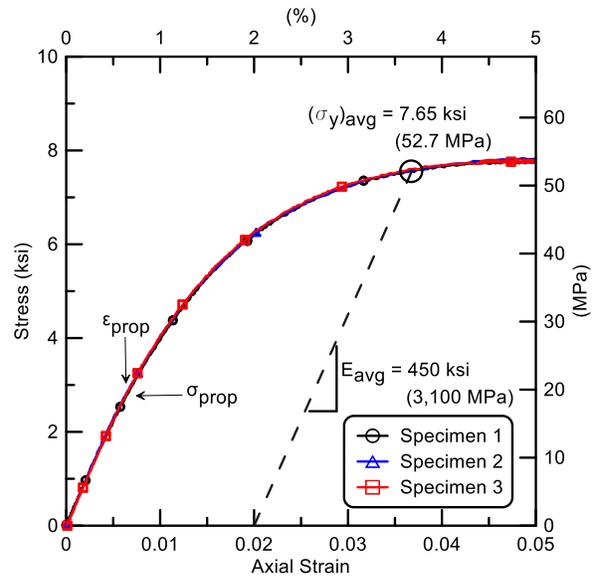
Figure 2.4. Average Young's Modulus and Yield Stress from Strain Gage

An expanded view of the stress vs. strain data is shown in Figure 2.4, in which the axial strain gage measurements were used to plot stress vs. strain to a level just beyond the elastic range. The results of all three tensile coupon tests show excellent agreement. Table 2.1 provides a summary of the Young's modulus, yield stress, peak tensile stress and strain, proportional limit and strain, ultimate tensile stress and strain, and Poisson's ratio determined from the tensile coupon specimens.

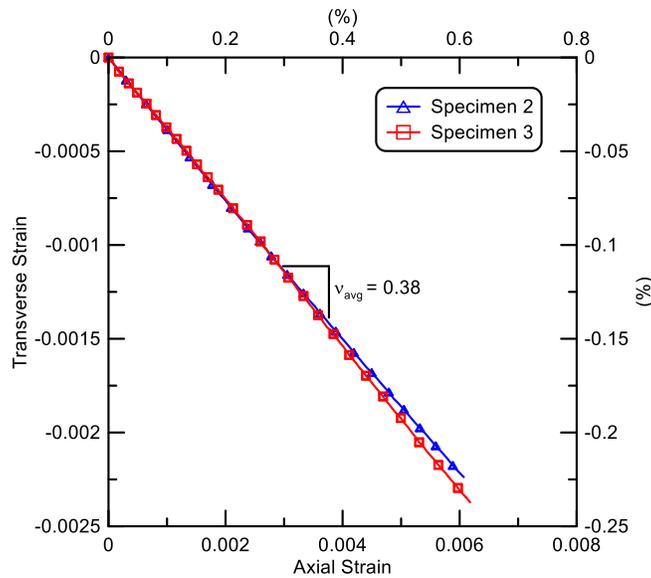
Figure 2.5. Transverse vs. Axial Strain for Tensile Stress Below Proportional Limit

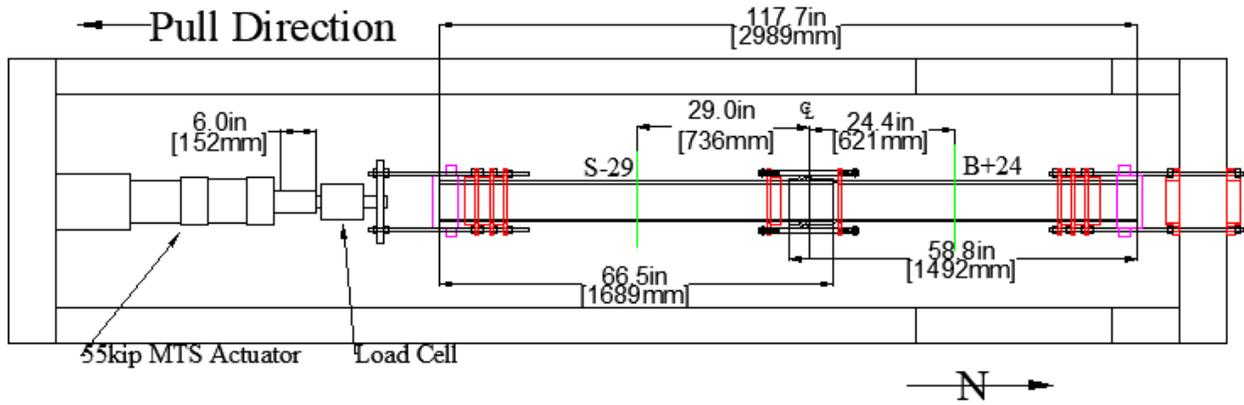
Figure 3.1. Plan View of Axial Tension Test

Figure 3.1 shows a plan view of the tension test setup and key instrumentation. The instrumentation listed in Table 3.1 was identical for each tension test. An actuator and load cell were installed at the south end of the load frame to apply and measure tensile force, respectively. The actuator had a tensile load capacity of 55 kips (245 kN) and stroke of 6 in. (150 mm). A series of three wedge

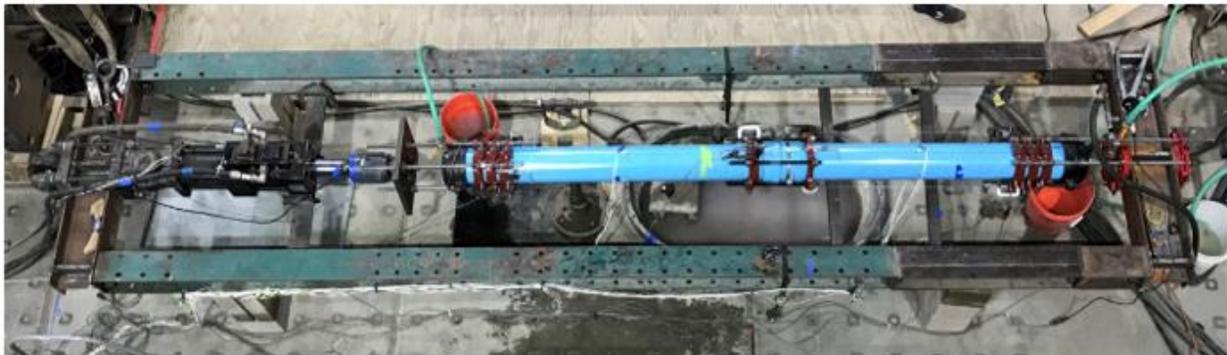
Figure 3.2. Test Apparatus and TT1 Specimen in the Direct Tension Frame

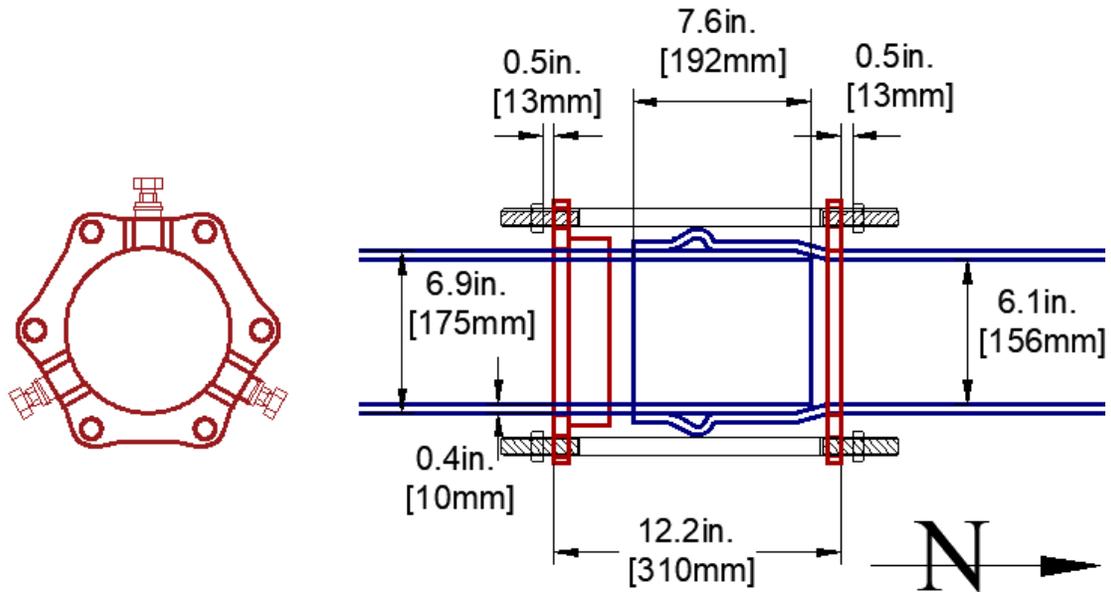
Figure 3.3. Cross-section of Restrained Pipe Joint

Figure 3.3 shows a cross-section of the restraint as assembled for testing with the positions and dimensions of all components. Six 0.75 in. (19 mm) threaded rods span the restraining collars at either side of the joint. Nuts on the threaded rods were loosened before the start of the test to allow approximately 1 in. (25 mm) of pullout before contact between the nuts on the threaded rods and the collars of the restraint.

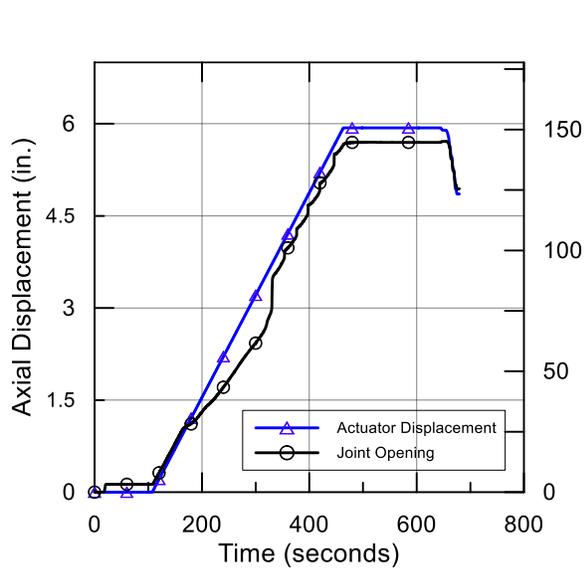
Figure 3.5. Actuator and Joint Displacement vs. Time for TT1 Specimen

25 to 100 seconds) was caused by Poisson's effect, which involves shortening of the specimen due to circumferential stresses induced by internal pressurization.

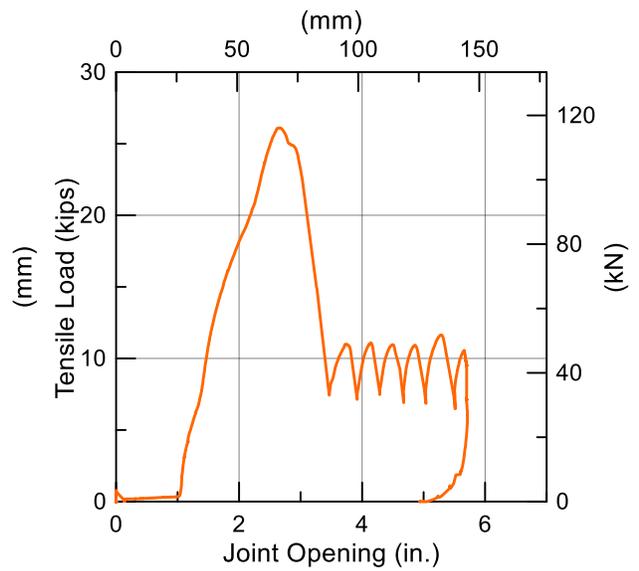
Figure 3.6. Tensile Load vs. Displacement for TT1 Specimen

The TT1 pipe attained a maximum tensile load of 26 kips (116 kN) at a joint opening of 2.65 in. (67 mm). Once this maximum load was achieved, further axial displacement was accompanied by six episodes of abrupt ratcheting movement when pullout of the spigot occurred at approximately 6 in. (150 mm). The TT2 pipe attained a maximum load of 28 kips (125 kN) at 2.79 in. (71 mm) of joint opening, after which the load dropped steeply to 25 kips (111 kN) followed immediately by brittle rupture of the spigot at the joint restraint.

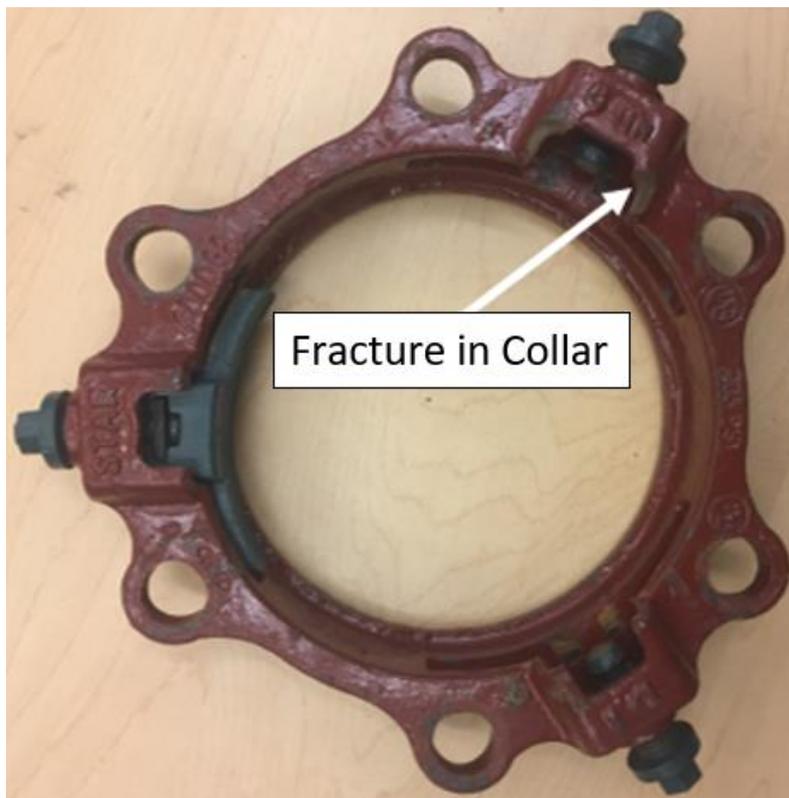
Figure 3.7. Fracture of Wedge Action Restraint

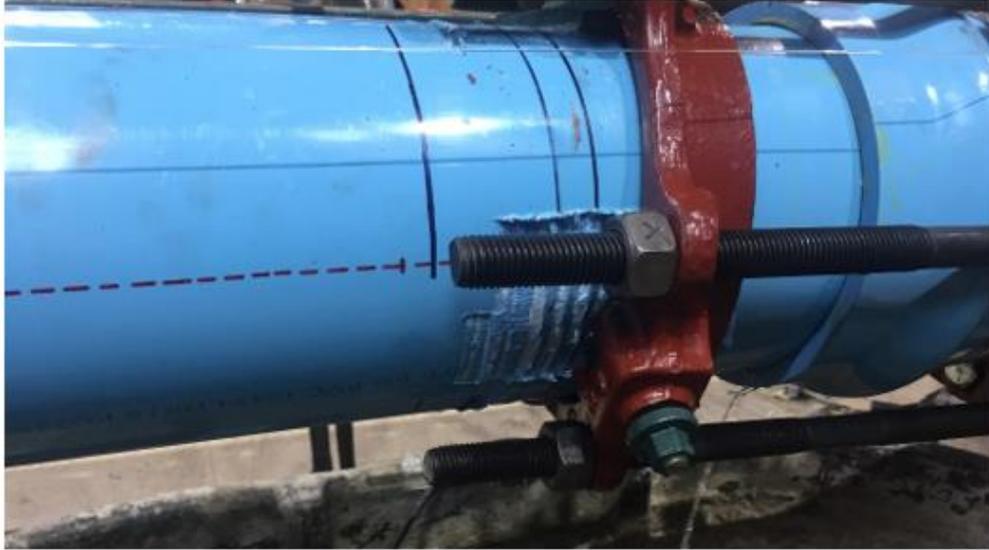
Figure 3.8. Fracture of Restraining Collar Clamping Tooth Housing

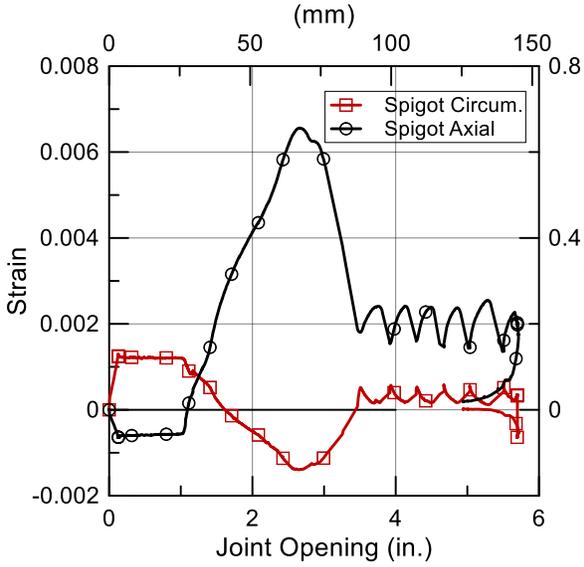
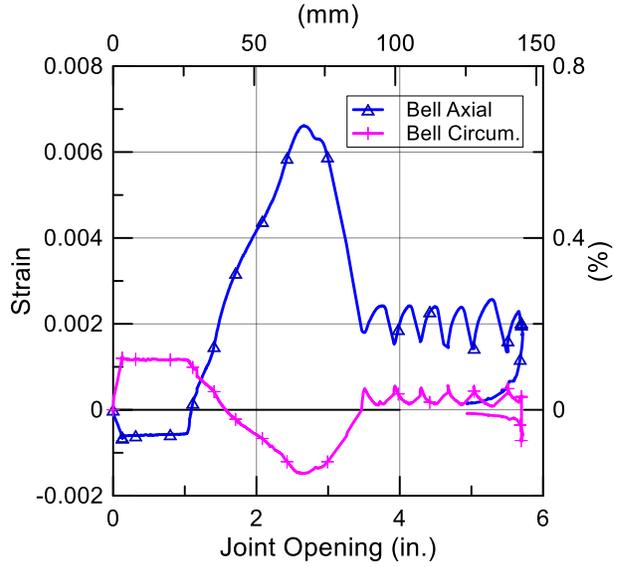
(a) Average Spigot Strains

(b) Average Bell Strains

Figure 3.9. TT1 Pipe Strains at North and South Gage Planes

Strain gage results are presented for the axial and circumferential strain gages at the north and south midpoints of the pipe (planes S-29 and B+24). The gage measurements were used to provide a redundant measuring system for applied axial forces, assess the influence of internal pressure on circumferential strains, and to obtain a more comprehensive understanding of the pipe deformation.

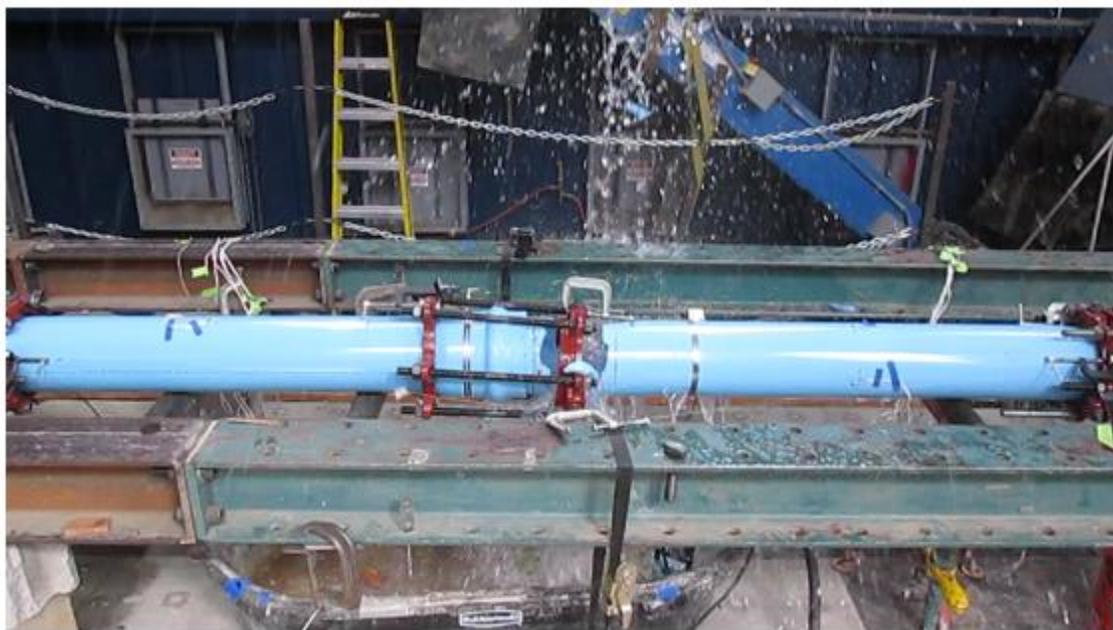
Figure 3.10. Photo of TT2 Specimen at Failure

The same testing setup and procedure for TT1 was followed for TT2. Figure 3.10 shows a photo of the test at failure. Figure 3.11 shows the actuator displacement and joint opening vs. experimental time for the second tension test. Similar to TT1, the small joint opening that occurs at the beginning of the test ($t = 90$ to 110 seconds) can be attributed to the Poisson's effect induced by internal pressurization. The applied displacement and joint opening are approximately equal up to an axial displacement of about 1.5 in. (38.1 mm). At this point, the test was paused ($t = 200$ to 400 seconds) to reset the actuator to its full capacity and check all instrumentation. Figure 3.12 is a plot of the axial tension force vs. joint opening for TT2. The peak tensile load of about 28 kips (125 kN) occurred at 2.79 in. (71 mm) of joint opening. After reaching the peak load, the axial

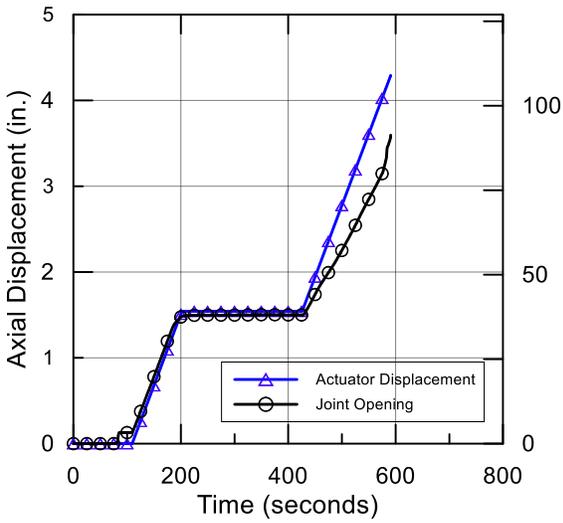
Figure 3.11. Actuator and Joint Displacement vs. Time for TT2 Specimen

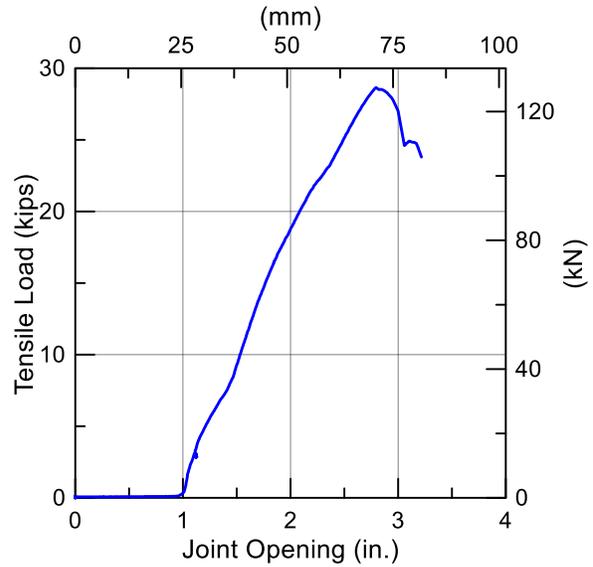
Figure 3.12. Tensile Load vs. Displacement for TT2 Specimen

force dropped sharply to less than 25 kips (111 kN) over 0.27 in. (6.9 mm) of joint opening. This drop in load can be attributed to the fracture of one of the three clamping teeth housings of the wedge action restraint as displayed in Figure 3.7. As shown in Figure 3.13(a)-(d), the remaining two clamping teeth rotated in the direction of the applied force, pinching into the pipe and causing failure. As Figure 3.10 shows, brittle failure of the specimen occurred at a joint opening of 3.2 in. (81.3 mm).

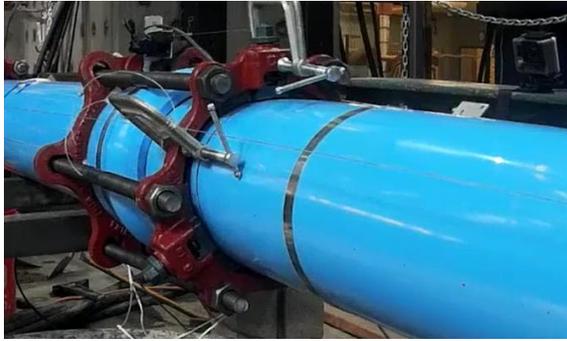
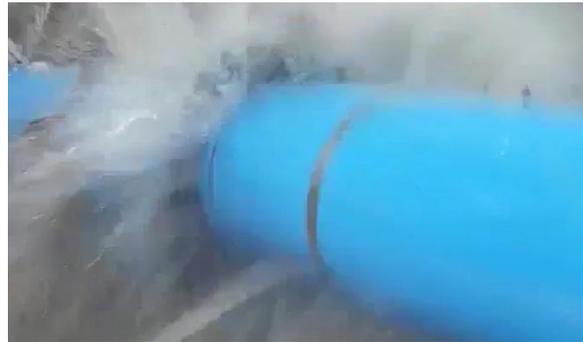
(c) Clamping Teeth Induce Pinching Effect

(d) Failure

Figure 3.13. TT2 Joint Mechanism – Rotation of Clamping Teeth

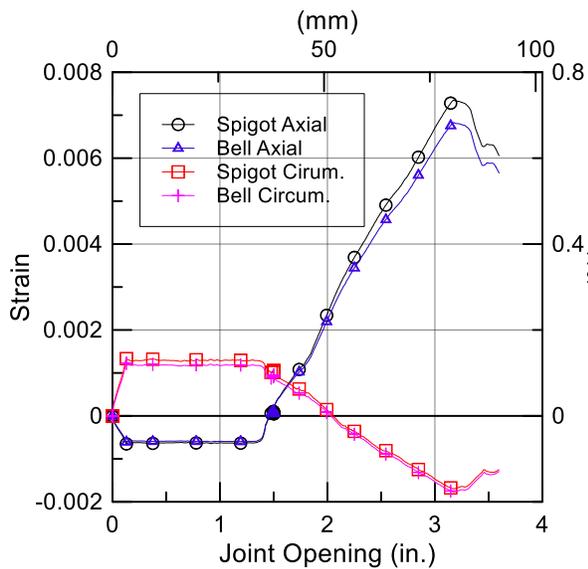
Figure 3.14. TT2 Pipe Strains at North and South Gage Plane

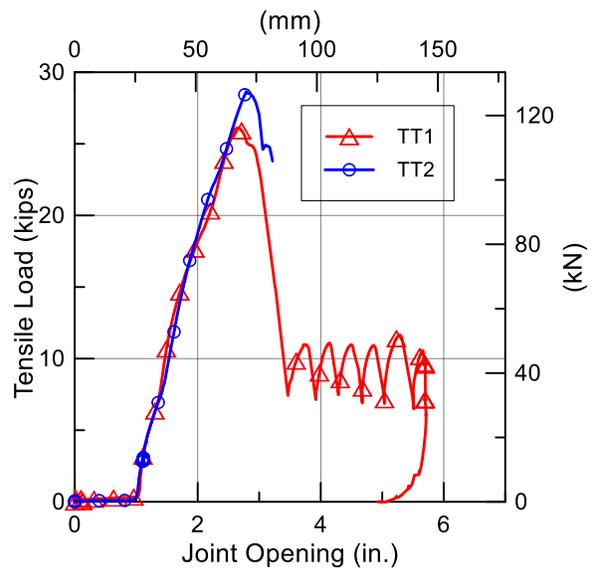
Figure 3.15. Tensile Load vs. Joint Opening Comparison

A comparison of the overall tensile load in relation to joint opening is shown in Figure 3.15 for the two separate tension tests. In both tests, fracture at the south restraining collar at the housings

of the clamping teeth directly contributed to failure. In TT1, the collar fractured at two of these locations, allowing the pipe joint to open as the collar slipped relative to the pipe. In TT2, the collar fractured at one of these locations, leading to a brittle failure attributed to the concentrated strain created by the remaining two clamping teeth. TT1 reached a maximum tensile load of about 26 kips (116 kN) at a joint opening of 2.65 in. (67 mm), while TT2 reached a maximum tensile load of about 28 kips (125 kN) at a joint opening of 2.79 in. (71 mm). For TT1, no leakage was observed until after the actuator reached its full 6 in. (150 mm) displacement capacity. For TT2, the forces conveyed by the clamping teeth of the wedge action restraint led to a brittle failure of the specimen at 3.2 in. (81 mm) of joint opening. The average peak axial strain was slightly larger in TT2 at 0.0071 (7093 $\mu\epsilon$) compared with 0.0066 (6560 $\mu\epsilon$) mobilized in TT1. Both values were marginally larger than the strain at the proportional limit that was determined from tensile coupon specimens (peak strain \approx 0.0065).

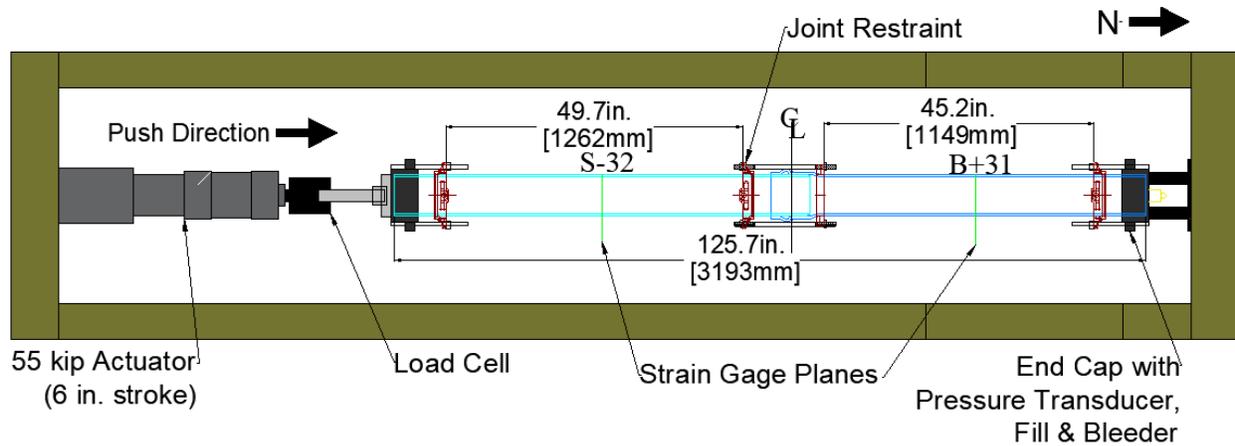
Figure 4.1. Plan View of Compression Test Specimen

Strain gages were applied at the midpoints of the bell (north) and spigot (south) pipe specimens for each compression test. The two planes were designated SG+31 and SG-32, as shown in Figure 4.1. Gage plane SG+31 was located on the pipe at 31 in. (787 mm) north of the specimen centerline. Gage Plane SG-32 was located on the pipe at 32 in. (813 mm) south of the specimen centerline. Each plane had gages located at the crown, invert, and west and east springlines in both the axial and circumferential directions.

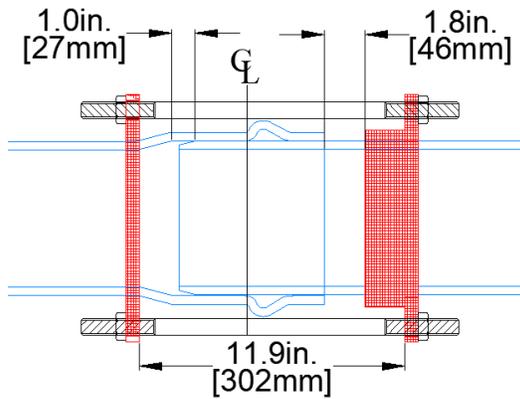
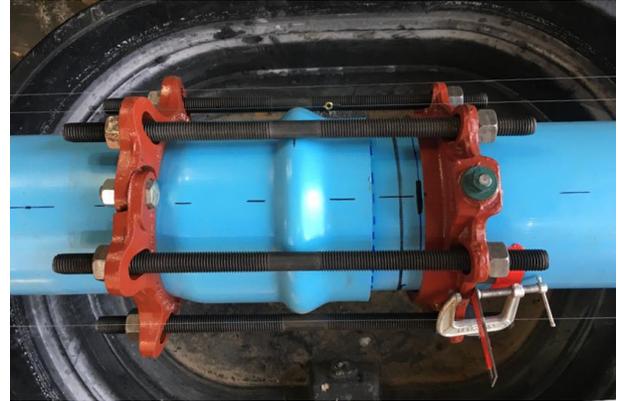
(a) Plan View of Joint Profile

(b) Initial Joint Condition

Figure 4.2. Compression Test Setup

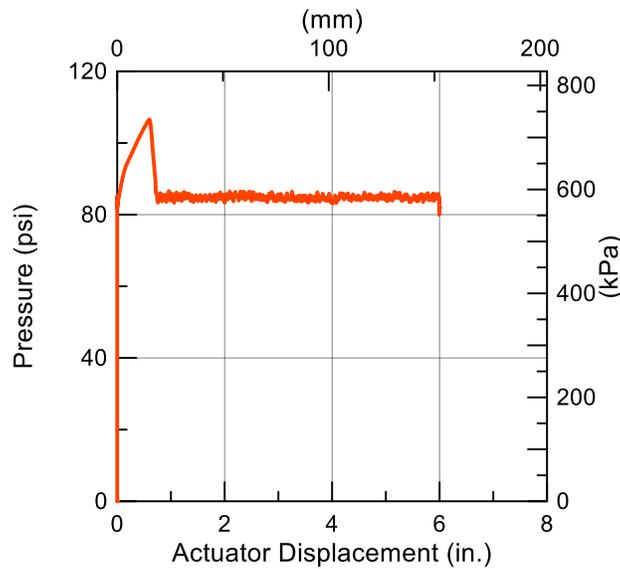
Figure 4.3. Internal Pressure vs. Actuator Displacement for CT1

The first compression test was run at a rate of 1 in. (25 mm) per minute. The internal water pressure vs. actuator displacement for CT1 is plotted in Figure 4.3. After being set to approximately 80 psi (550 kPa) to begin the test, the pressure rises to a maximum of 106 psi (731 kPa) over the first 1 in. (25.4 mm) of displacement before a relief valve allowed the pressure to decrease and remain near 85 psi (586 kPa) for the remainder of the test. The specimen did not leak or rupture at any time during the testing sequence. All compressive movement occurred without compromising the internal seal provided by the gasket at the joint of the specimen.

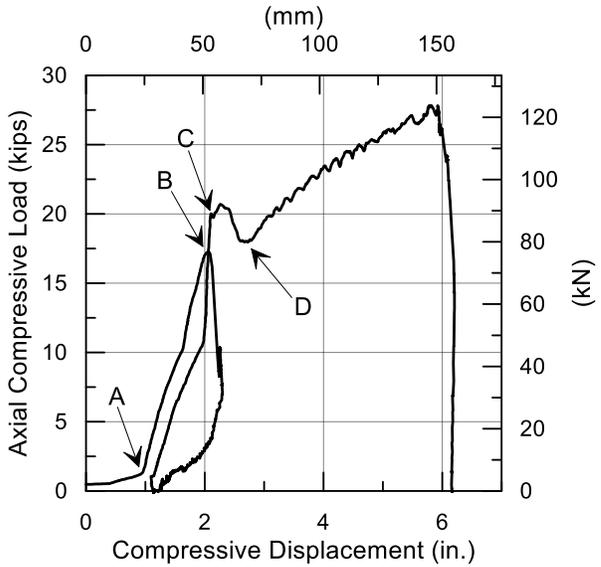
Figure 4.4. Axial Compressive Load vs. Joint Displacement for CT1

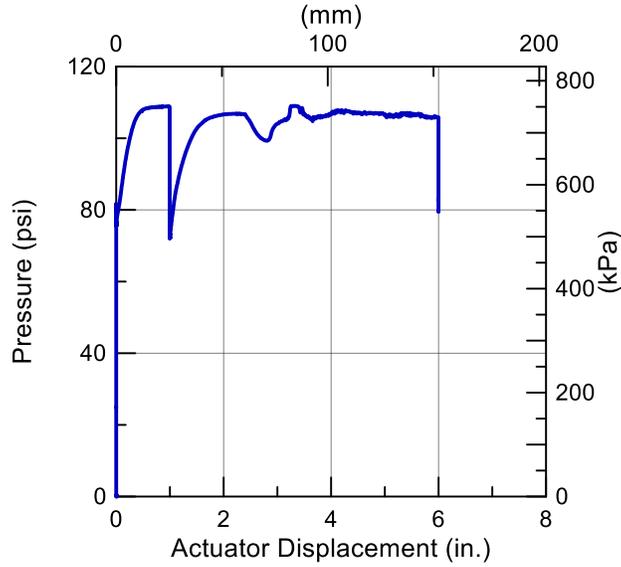
Figure 4.7. Internal Pressure vs. Actuator Displacement for CT2

This section presents experimental results from the second (CT2) of three compression tests. CT2 was run at a rate of 10 in./min. (254 mm/min.). The internal water pressure vs. actuator displacement for CT2 is plotted in Figure 4.7. After being set to approximately 80 psi (550 kPa) to begin the test, the pressure rises to a maximum of 109 psi (751 kPa) over the first 1 in. (25.4 mm) of displacement before a relief valve allowed the pressure to decrease when the test was paused to verify instrumentation response. Pressure increased again and remained relatively constant at 108 psi (744 kPa) for the final 5 in. (127 mm) of actuator displacement. The specimen

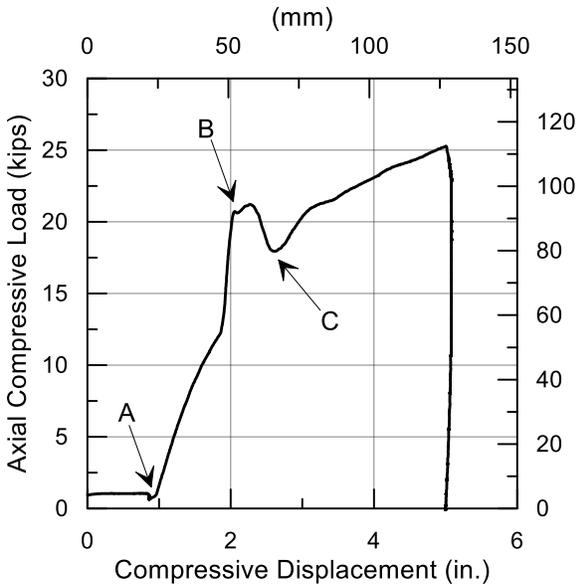
Figure 4.8. Axial Compressive Load vs. Joint Displacement for CT2

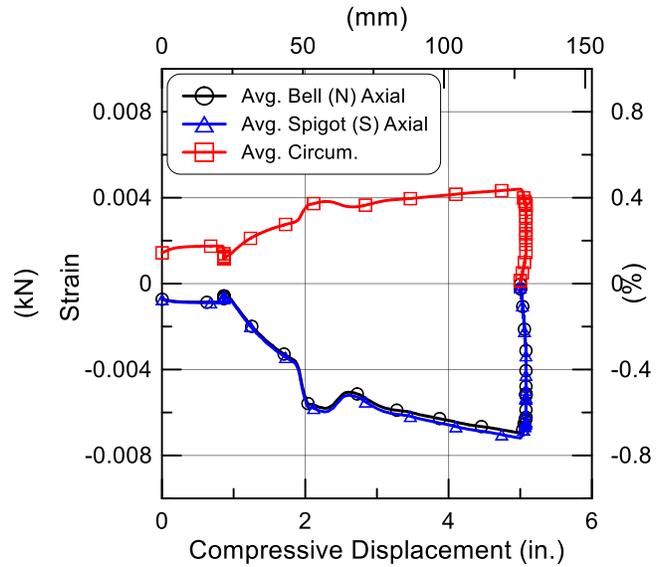
Figure 4.9. Pipe Strains on Bell and Spigot Planes for CT2

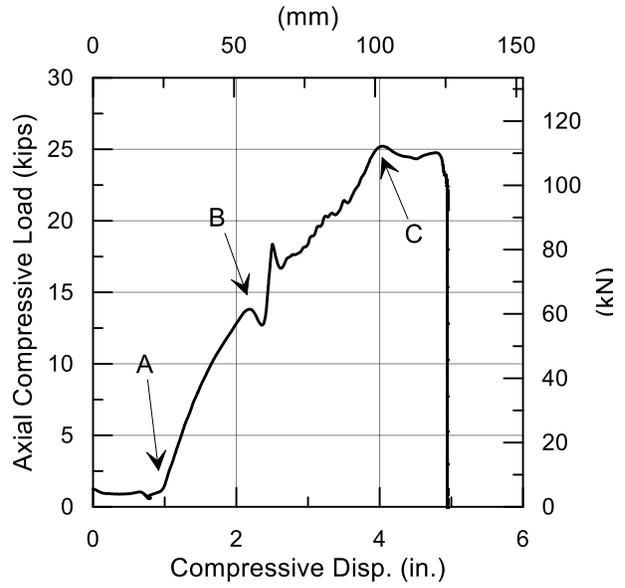
Figure 4.11. Axial Compressive Load vs. Joint Displacement for CT3

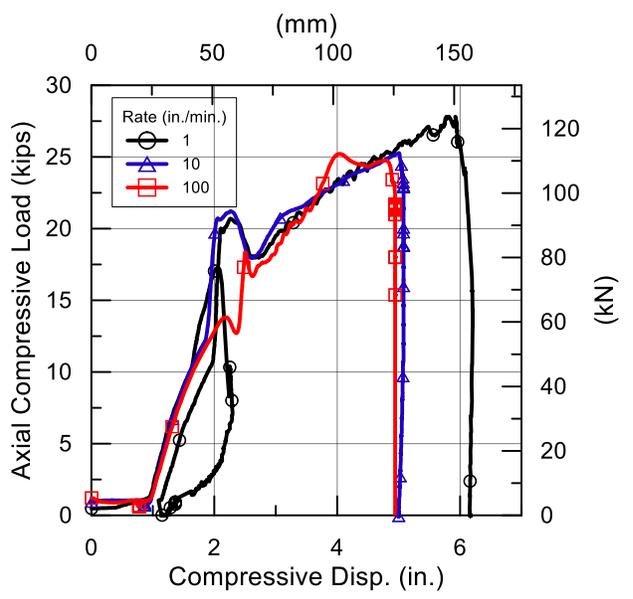
Figure 4.13. Compression Test Load vs. Displacement Comparison

Through a change in rate of loading of over two orders of magnitude, the iPVC pipe with Stargrip® Gen2 joint restraints was able accommodate substantial compressive deformation with no failure or leakage under internal water pressure. For all three rates of loading, there is virtually no difference in the compressive load vs. axial displacement response. The compressive axial stiffness of the joint and restraint is essentially independent of loading rate for the three rates of loading investigated.

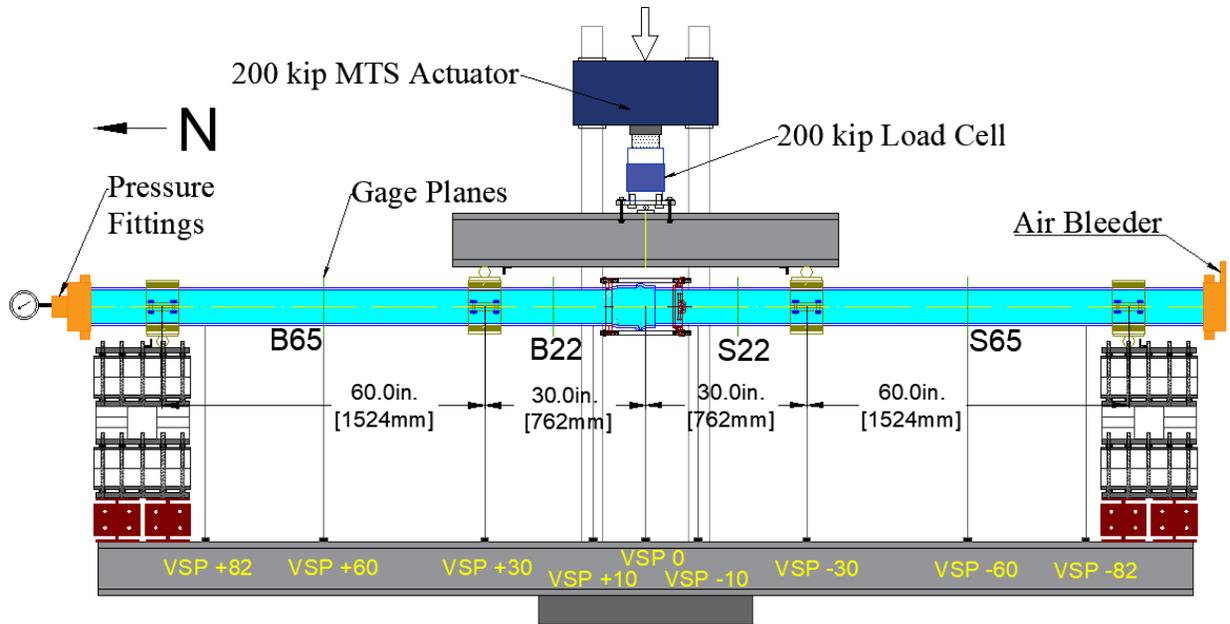
Figure 5.1. Profile View of Bending Test Including Instrumentation Location

Table 5.1 is a list of all instruments used during the bending test. A pressure transducer was employed at the north end cap to measure internal water pressure. Four planes of strain gages were installed along the specimen. Nine string potentiometers (string pots) were utilized to measure vertical displacements along the specimen. The gage planes and locations of string pots are shown in Figure 5.1. String pots were attached to the base of the frame and fixed to the invert of the specimen at intervals of 10, 30, 60, and 82 in. (250, 760, 1520, and 2080 mm, respectively) on either side of the specimen centerline. Each string pot is identified by its distance from the centerline. For example, VSP-10 was positioned 10 in. (250 mm) south of the centerline. Two additional string pots were used at the crown and invert of the joint to measure horizontal movement and rotation of the joint during deflection.

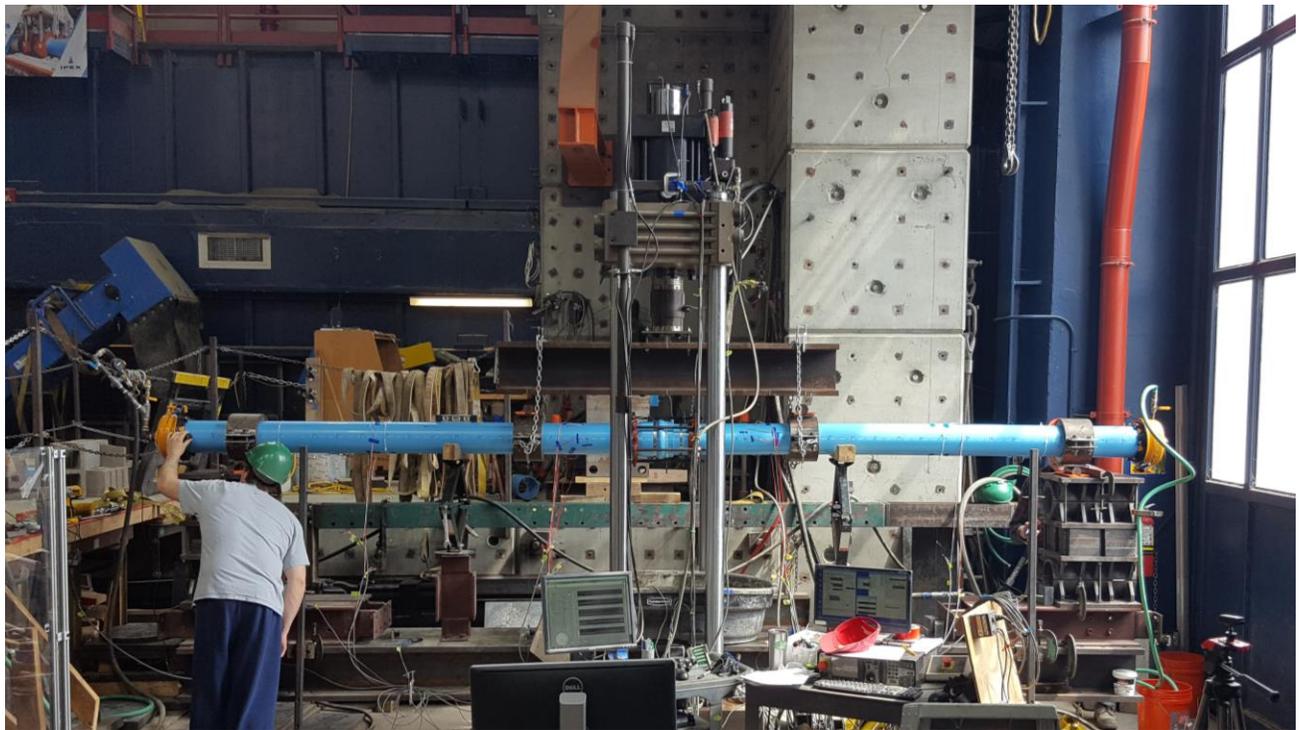
Figure 5.2. Photo of Bending Test Setup

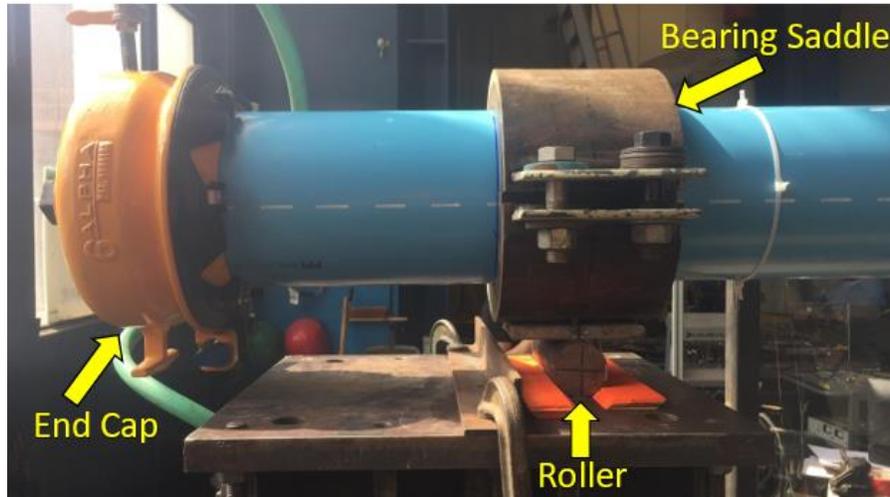
Figure 5.3. South Loading Support with End Cap, Roller and Saddle

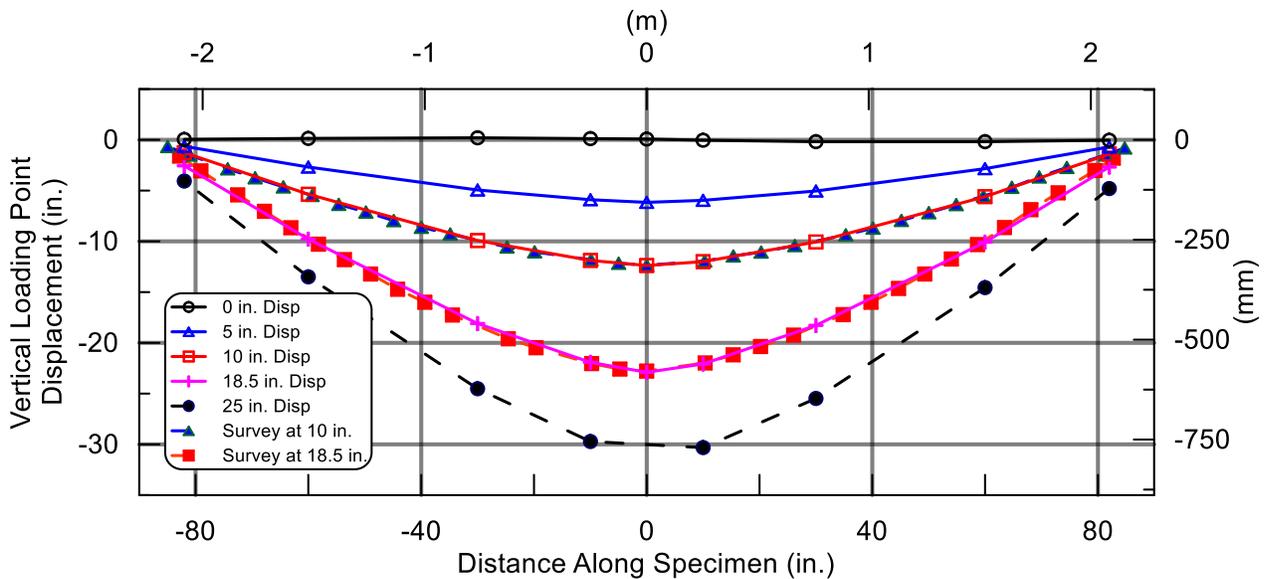
Figure 5.6. Vertical Displacements Along the Pipe Specimen

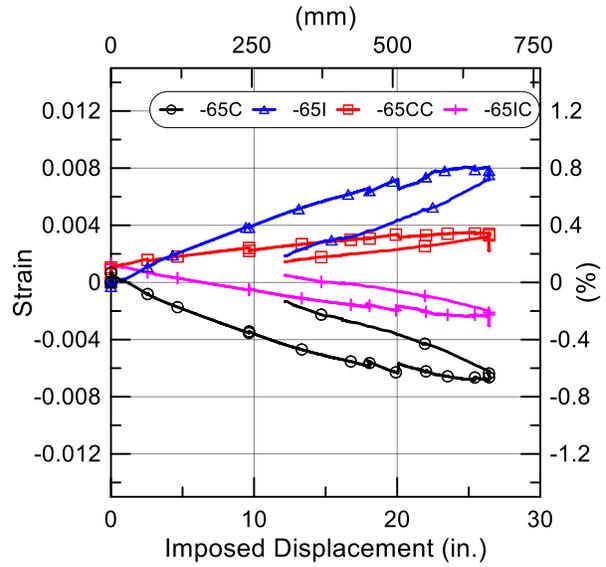
Figure 5.8. Strains Measured at the Crown and Invert of Plane SG-65

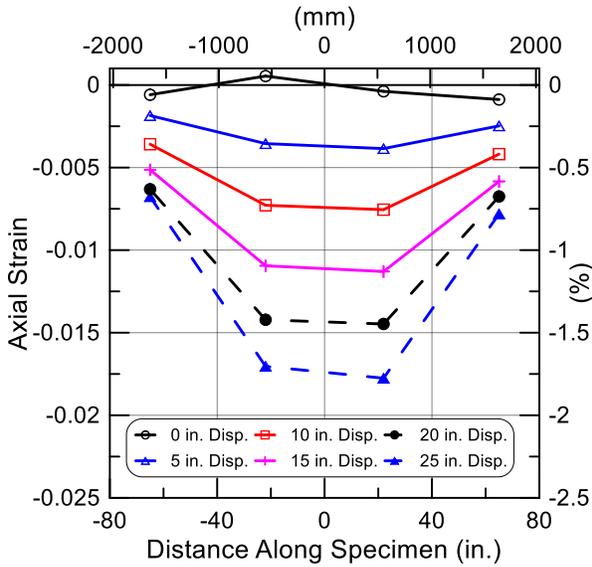
Figure 5.11. Crown Strains at Various Levels of Loading

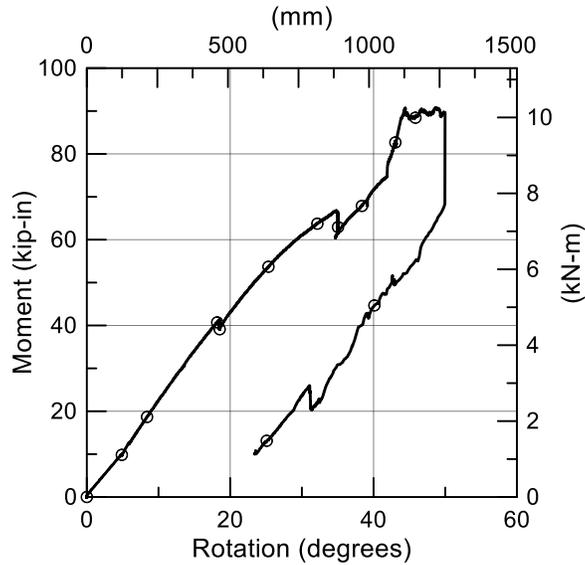
Figure 5.13. Moment vs. Specimen Rotation

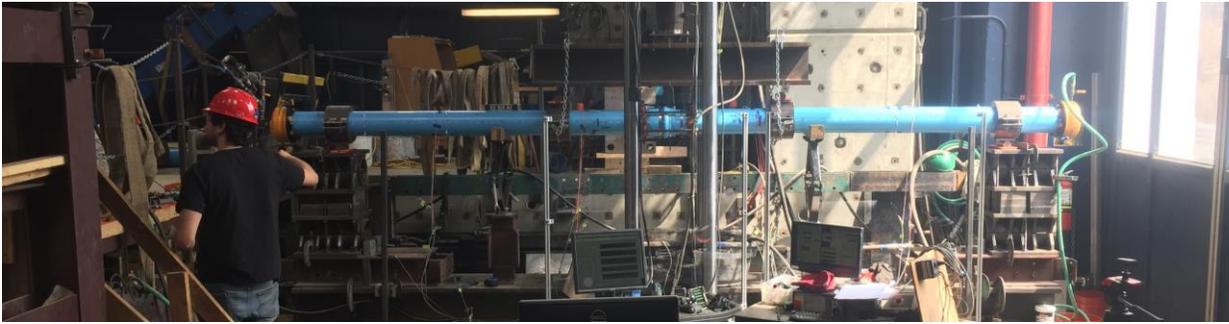
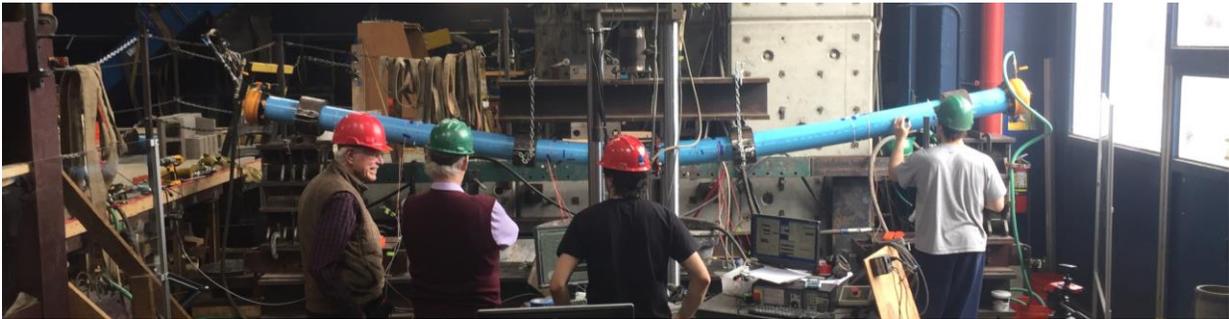
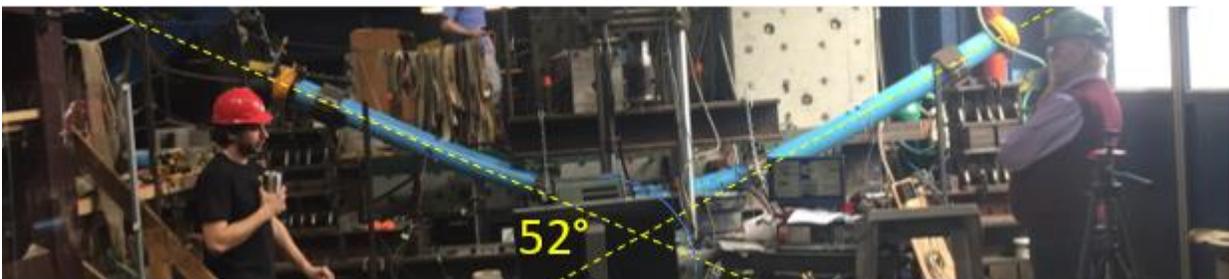
(a) Initial Position

(b) 10 in. (254 mm) of Displacement

(d) 26.5 in. (673 mm) of Displacement (Maximum Displacement)

Figures 5.14a, b, c, and d show photos of the initial position of the specimen, as well as its position at 10 in. (254 mm), 18.5 in. (470 mm), the maximum 26.7 in. (678 mm) of vertical displacement, respectively. This sequence of photos shows graphically the ability of the specimen to accommodate a large amount of deflection without failure or leakage. The maximum deflection occurred at 52.2 degrees of rotation, as shown and defined in Figure 5.14d.

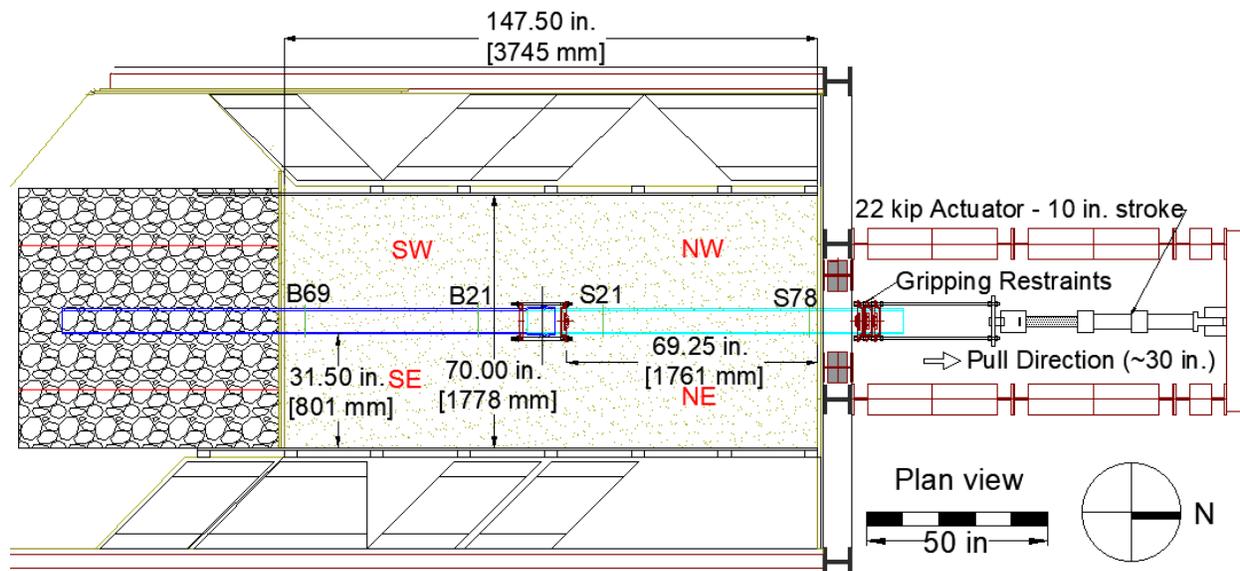
Figure 6.1 Plan View of Axial Pull Test Setup

As shown in Figure 6.1, each specimen was gripped at the outside of the split basin with three Stargrip® Gen2 wedge action restraints in series and connected to an MTS servo-controlled hydraulic actuator mounted to the end of a rigid reaction frame. Load was applied through rods connected to the hydraulic actuator that was mounted to the frame. The actuator had a 22-kip (98-
