Performance Evaluation of iPVC Pipe under Earthquake-Induced Ground Deformation

Cornell University

December, 2018

This report is submitted to the Pyungwha Pipe Industry Co., Ltd. (herein referred to as PPI). It presents the results of a full-scale testing program to investigate the performance of 6-in. (150-mm)-diameter polyvinyl chloride pipe with a minimum wall thickness of 0.383 in. (9.73 mm), commercially available as iPVC pipe, with restrained joints. Testing was performed to evaluate how pipelines composed of iPVC pipe accommodate large ground deformation. In particular, the testing program was focused on pipeline response to fault rupture. Fault rupture is not only a major ground deformation hazard associated with earthquakes, but is representative of the most severe seismic ground deformation that occurs along the margins of liquefaction-induced lateral spreads and landslides.

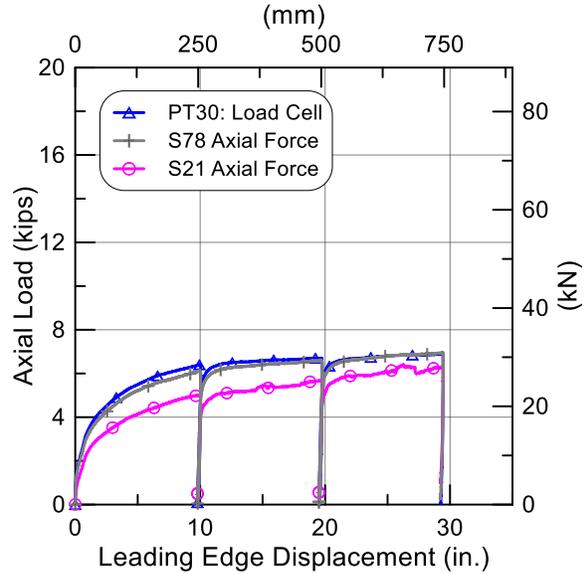
(b) Load Cell and Strain Gage Loads

Figure 6.3. PT30 Axial Load vs. Displacement for Actuator, Load Cell, and Strain Gage Loads

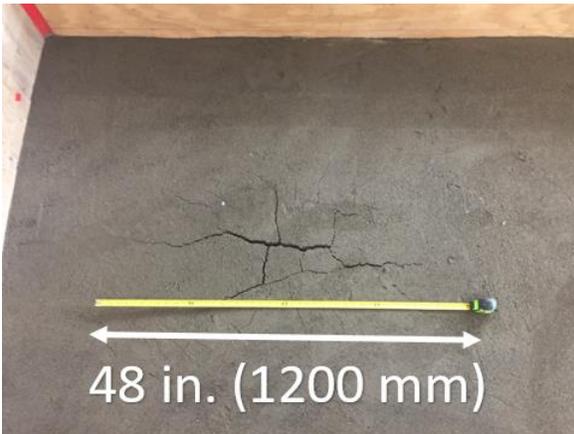
Figure 6.4. Soil Surface Cracking after PT30

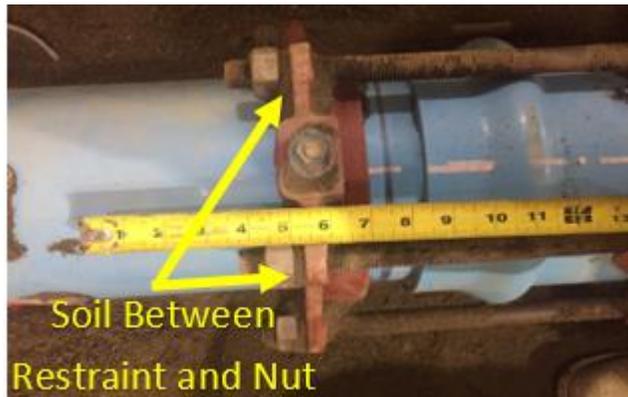
Figure 6.5. Photo of Sand Lodged Between Nuts and Collar of the Joint Restraint

The string pot measurements indicate that the joint opened a maximum 0.62 in. (15.8 mm) during the test. The joint was set to allow a maximum opening of 1 in. (25 mm). Like the first pull test, sand was observed again between the restraining collar and nuts, similar to what is shown in Figure 6.5.

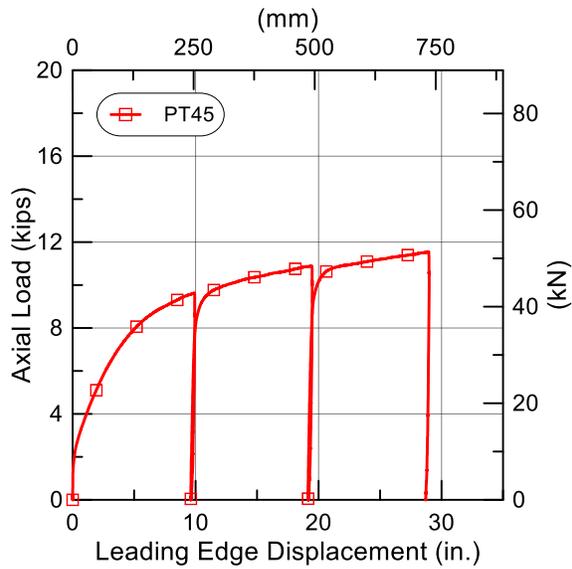
(a) Actuator Load Measurement

Figure 6.6. PT45 Axial Load vs. Displacement for Actuator, Load Cell, and Strain Gage Loads

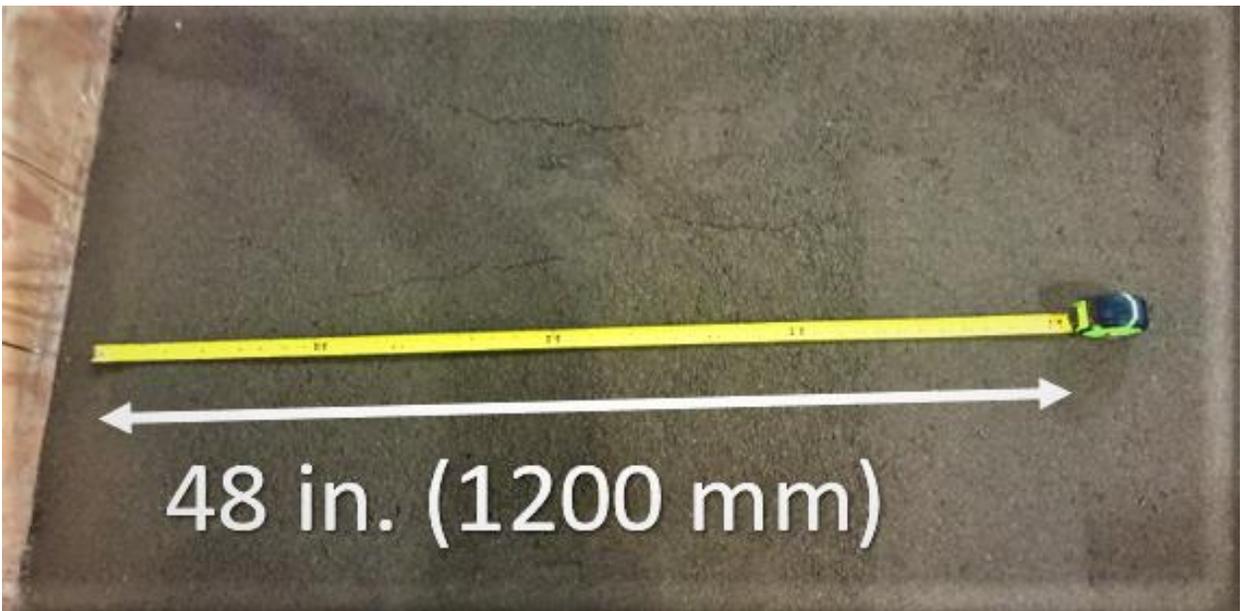
Figure 6.7. Soil Surface Cracking After PT45

Surface cracks again appeared during the test as shown in Figure 6.7. The cracking was less severe when compared to PT30, and reflects the shear distortion and volumetric expansion that is created as the restraint and pipe are pulled through the soil. The greater depth of soil cover results in less extensive surface cracks.

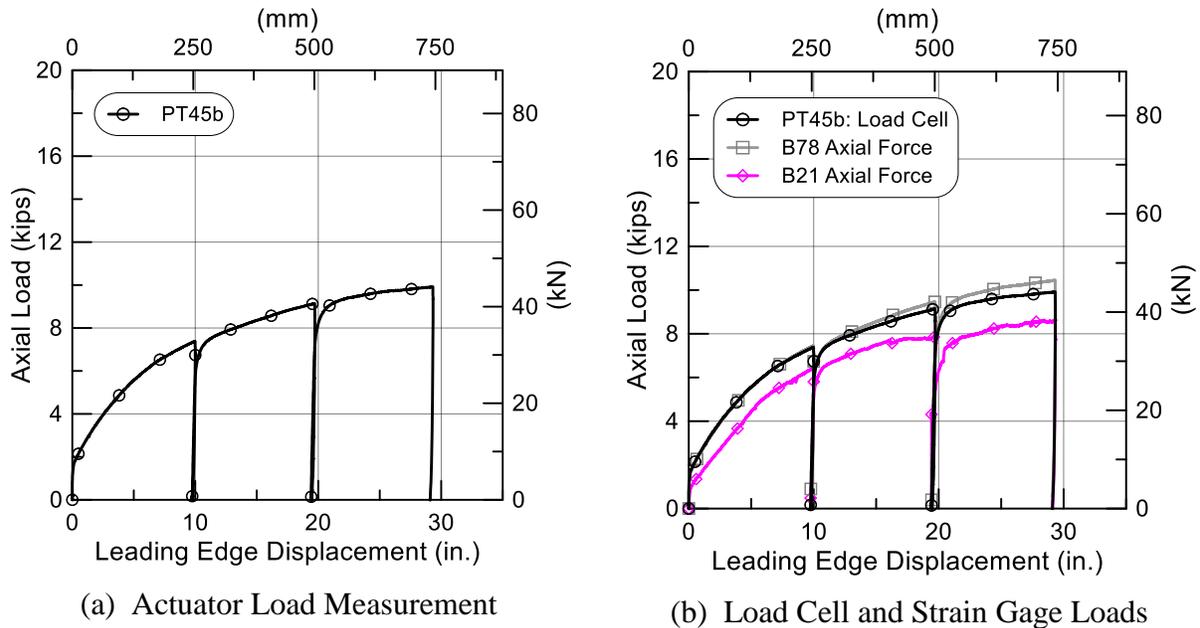
Figure 6.8. PT45b Axial Load vs. Displacement for Actuator, Load Cell, and Strain Gage Loads

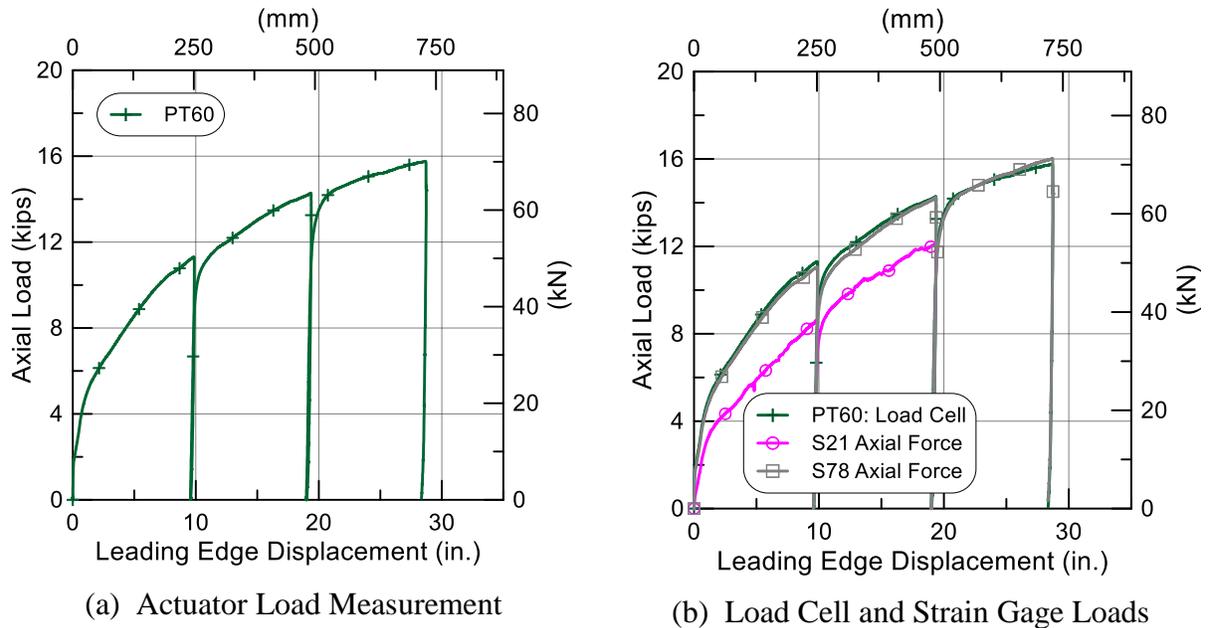
Figure 6.9. PT60 Axial Load vs. Displacement for Actuator, Load Cell, and Strain Gage Loads

The string pot measurements indicate that the joint opened a maximum 0.25 in. (6.35mm) during the test. The joint was set to allow a maximum opening of 1 in. (25mm). Like the other pull tests, sand was observed again between the restraining collar and nuts.

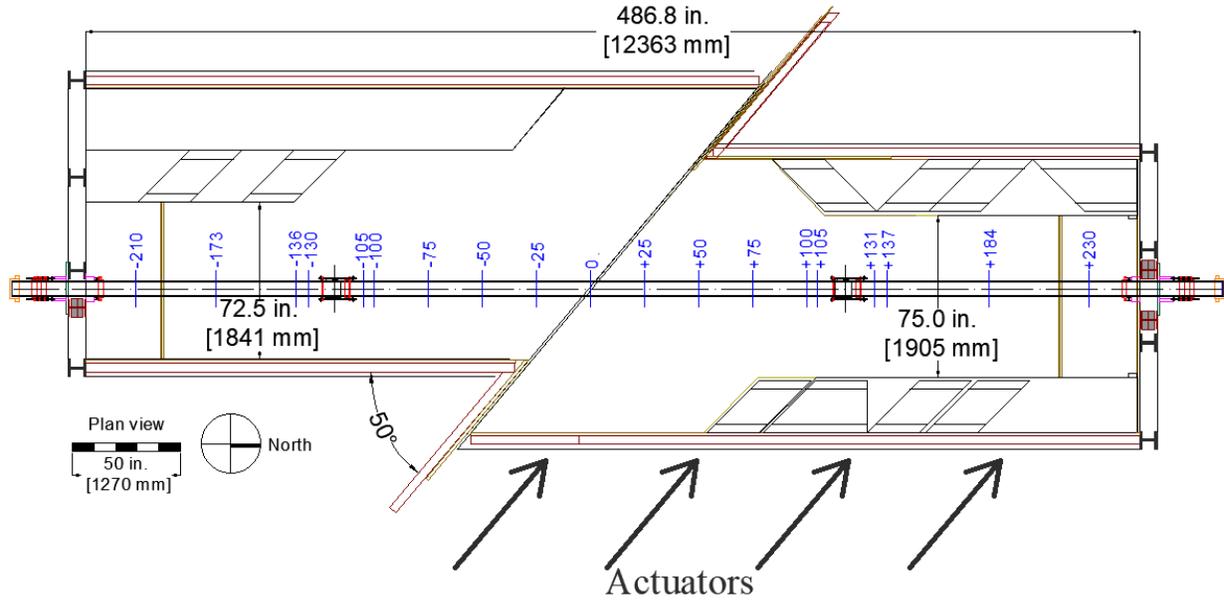
Figure 7.1. Plan View of Split Basin Testing Setup

A total pipeline length of 34.4 ft (10.5 m) was buried in soil between wooden retaining walls, which were located near the ends of the pipeline to allow access to instruments and end restraints. The total pipeline length from the north to south walls of the test basin was 40.3 ft (12.3 m). The ends of the pipe were fixed to each end of the split basin.

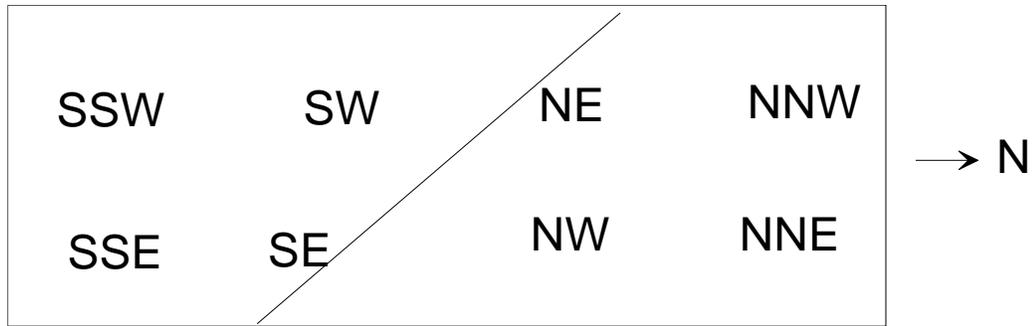
Figure 7.3 Plan View of Compaction Measurement Locations

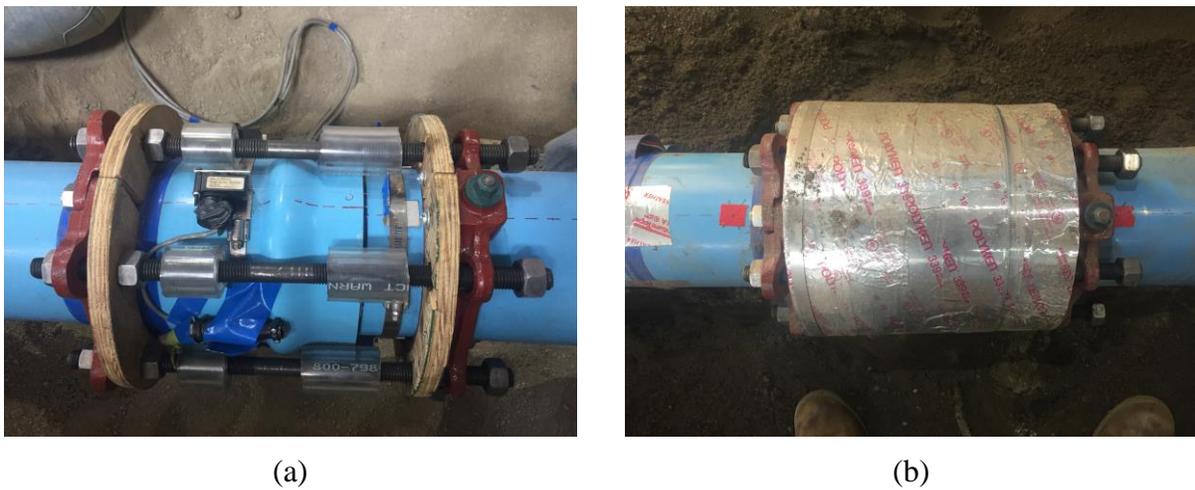
Figure 7.2. Instrumentation at (a) Restrained Joint and (b) Protective Enclosure

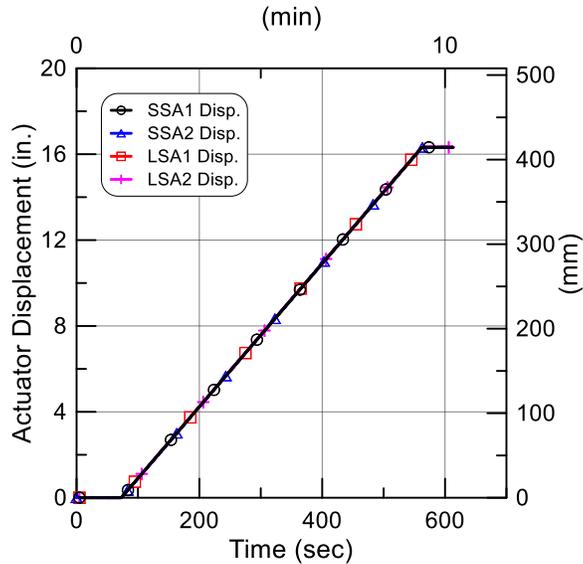
Figure 7.4. Actuator Displacement vs. Time

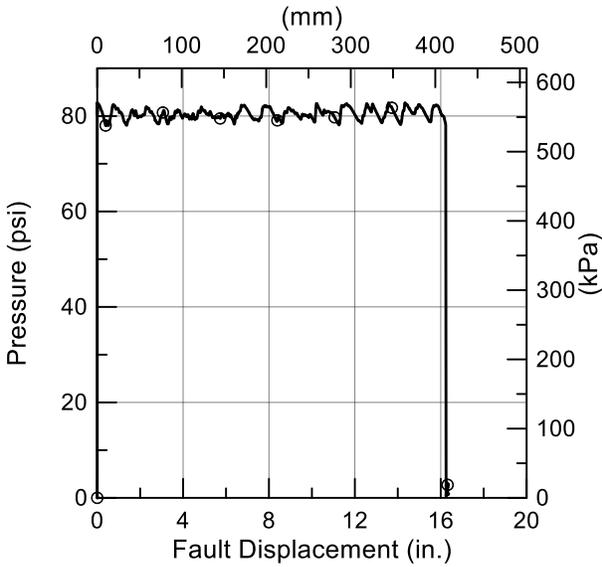
Figure 7.5. Internal Water Pressure vs. Fault Displacement

The test specimen was pressurized with internal water pressure of approximately 80 psi (552 kPa) through the duration of the test until failure of the pipeline. The internal pressure vs. fault displacement is shown in Figure 7.5. Water was able to flow into the test pipeline during elongation of the pipe caused by fault movement. Relatively small fluctuations in internal pressure occurred during elongation of the pipeline in response to fault rupture. Once pressure was applied at the

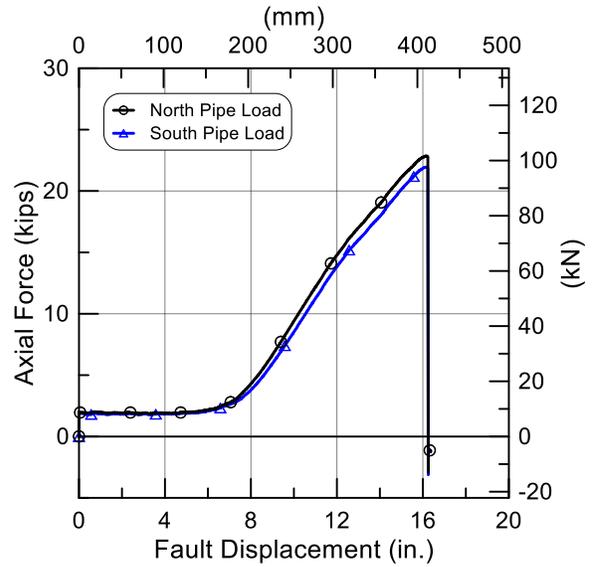
Figure 7.6. North and South Pipe End Loads vs. Fault Displacement

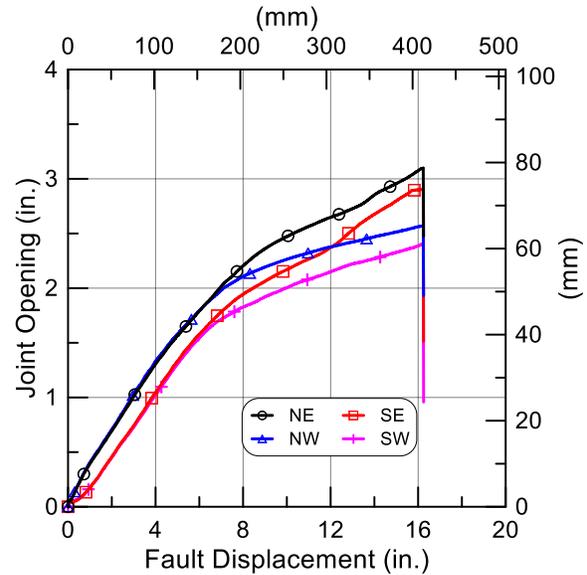
Figure 7.8. Joint Opening vs. Imposed Displacement

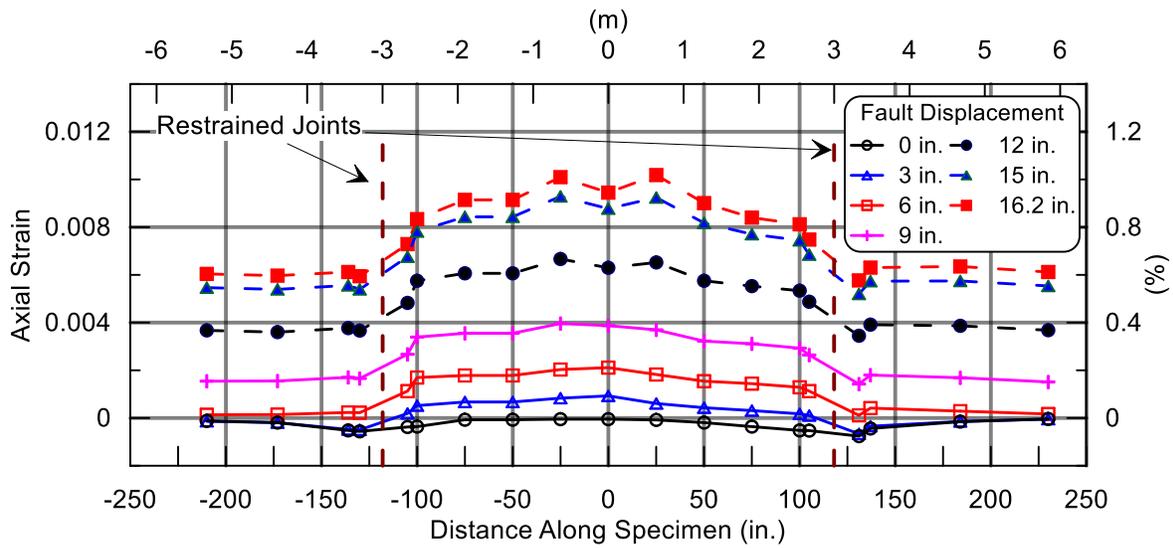
Figure 7.9. Distribution of Average Axial Strain Along the Specimen at Various Amounts of Fault Displacement

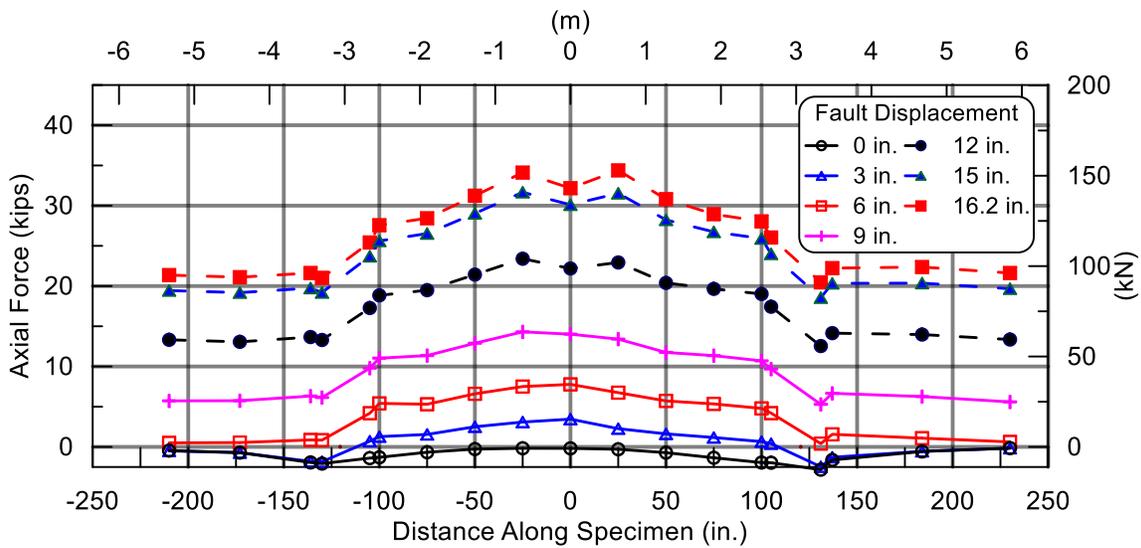
Figure 7.10. Distribution of Average Axial Force Along the Specimen at Various Amounts of Fault Displacement

The axial force distribution along the pipeline is shown in Figure 7.10. This force was calculated as $F = \epsilon AE$, where ϵ is the average axial strain at each gage plane location, A is the cross-sectional area of the specimen of 8.28 in.² (5342 mm²), and $E = 450.3$ ksi for the elastic range of the pipe response. To estimate axial loads outside the elastic range, Figure 2.4 was used to determine the secant modulus of the iPVC material at each level of tensile strain exceeding the proportional limit. This strain compatible secant modulus was used in the force equation above to estimate the axial load. There was a steady accumulation of axial load as fault movement increased. The maximum

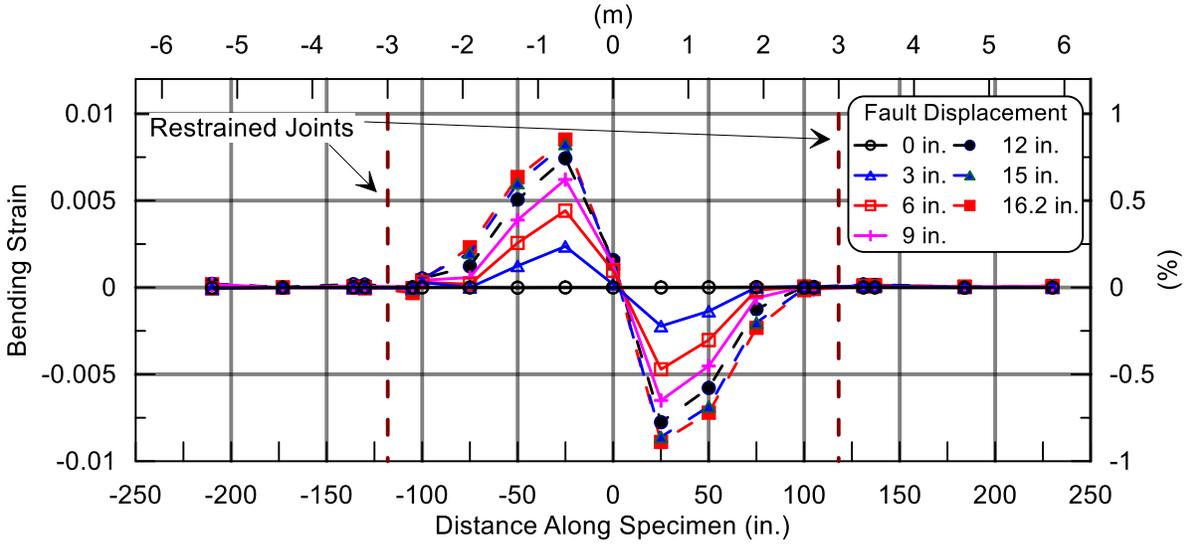
Figure 7.11. Distribution of Bending Strain Along the Specimen at Various Amounts of Fault Displacement

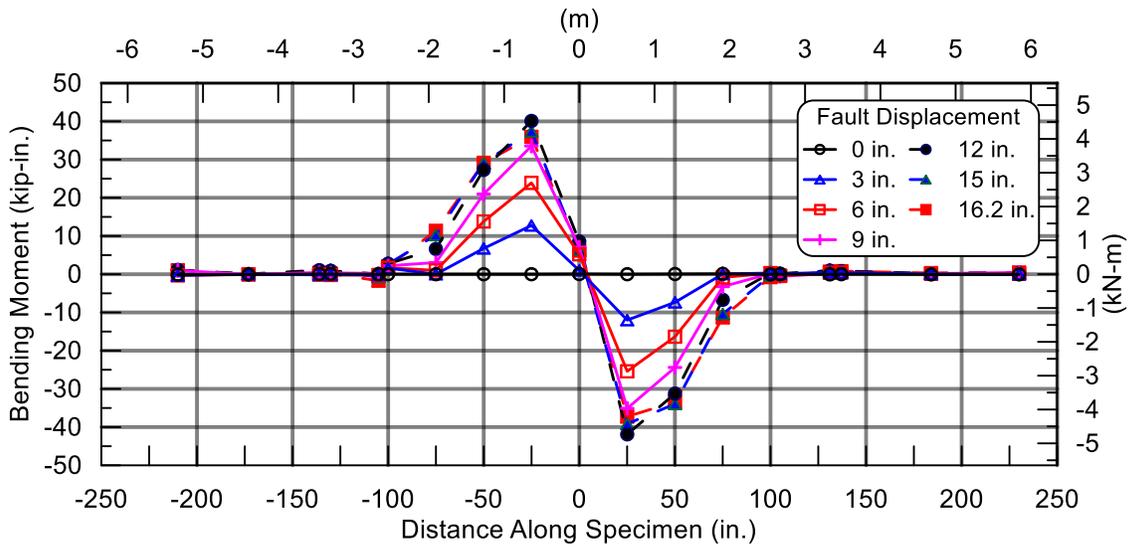
Figure 7.12. Distribution of Bending Moment Along the Specimen at Various Amounts of Fault Displacement

Figure 7.12 shows the calculated bending moment distribution along the specimen's length. The bending moment follows a very similar trend as the bending strain shown in Figure 7.11. For higher fault displacements, the imposed strains caused the pipe stresses to exceed the proportional limit, resulting in a lower nonlinear pipe stiffness.

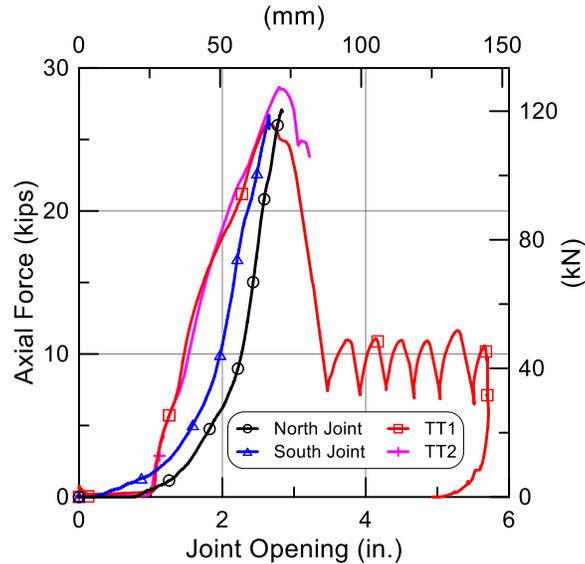
Figure 7.13. Joint Opening Comparison of Fault Rupture and Direct Tension Tests

At 16.2 in. (411.5 mm) of fault displacement, the pipe specimen ruptured just north of the south joint and internal pressure was lost. Figure 7.13 shows the opening of each joint in the fault rupture test as well as the joint opening measured in each tension test (TT1, TT2) versus force applied.

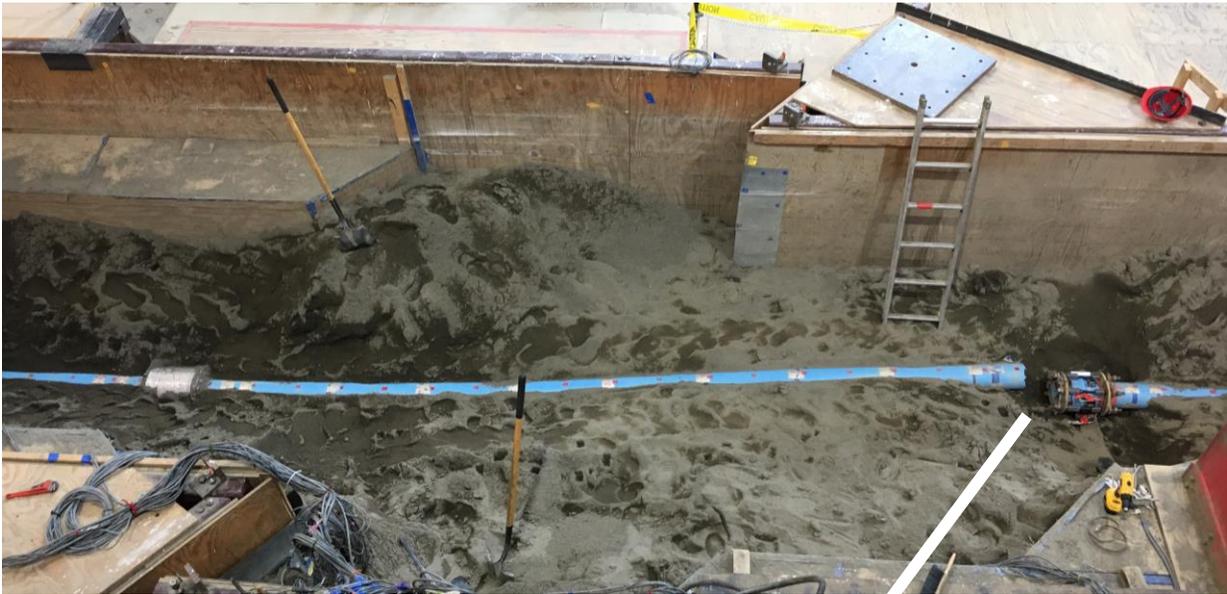
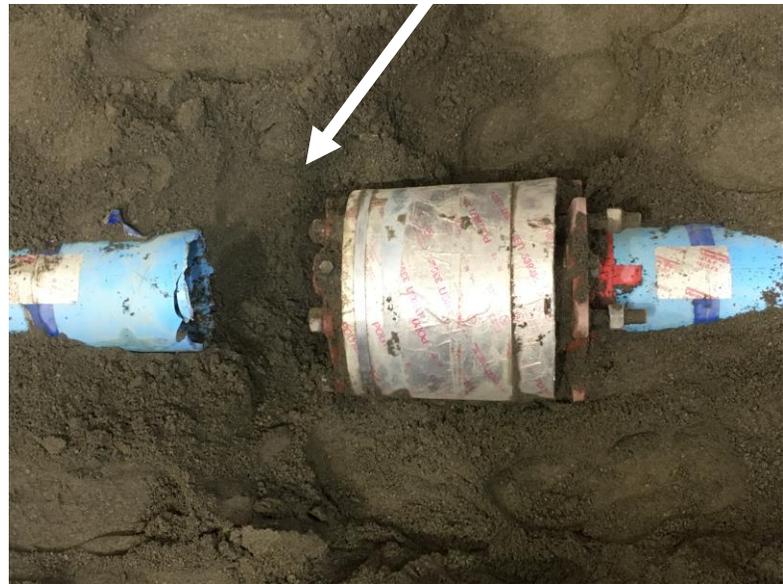
Figure 7.14. Overhead View of the (a) Pipeline and (b) Failed Joint After Excavation Following the Fault Rupture Test
